# City of Pittston Mine Subsidence Study

Presented at the 14<sup>th</sup> Annual  
Pennsylvania Statewide Conference on  
Abandoned Mine Reclamation,  
August 2-4 2012, State College, PA

# Pittston Mine Subsidence Study

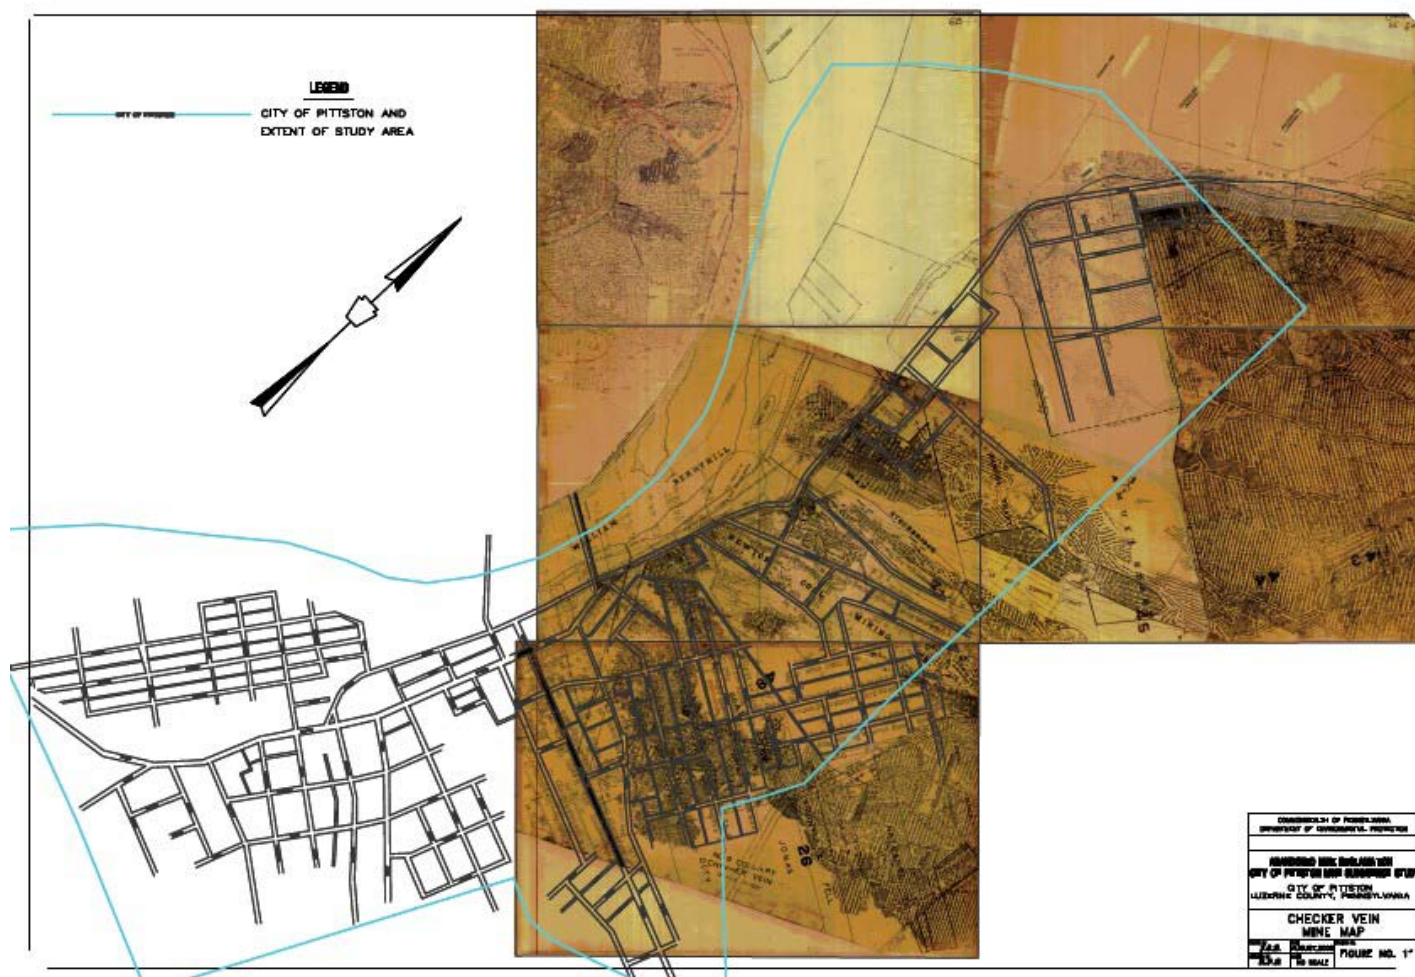
# Historical Mine Map – Checker Vein

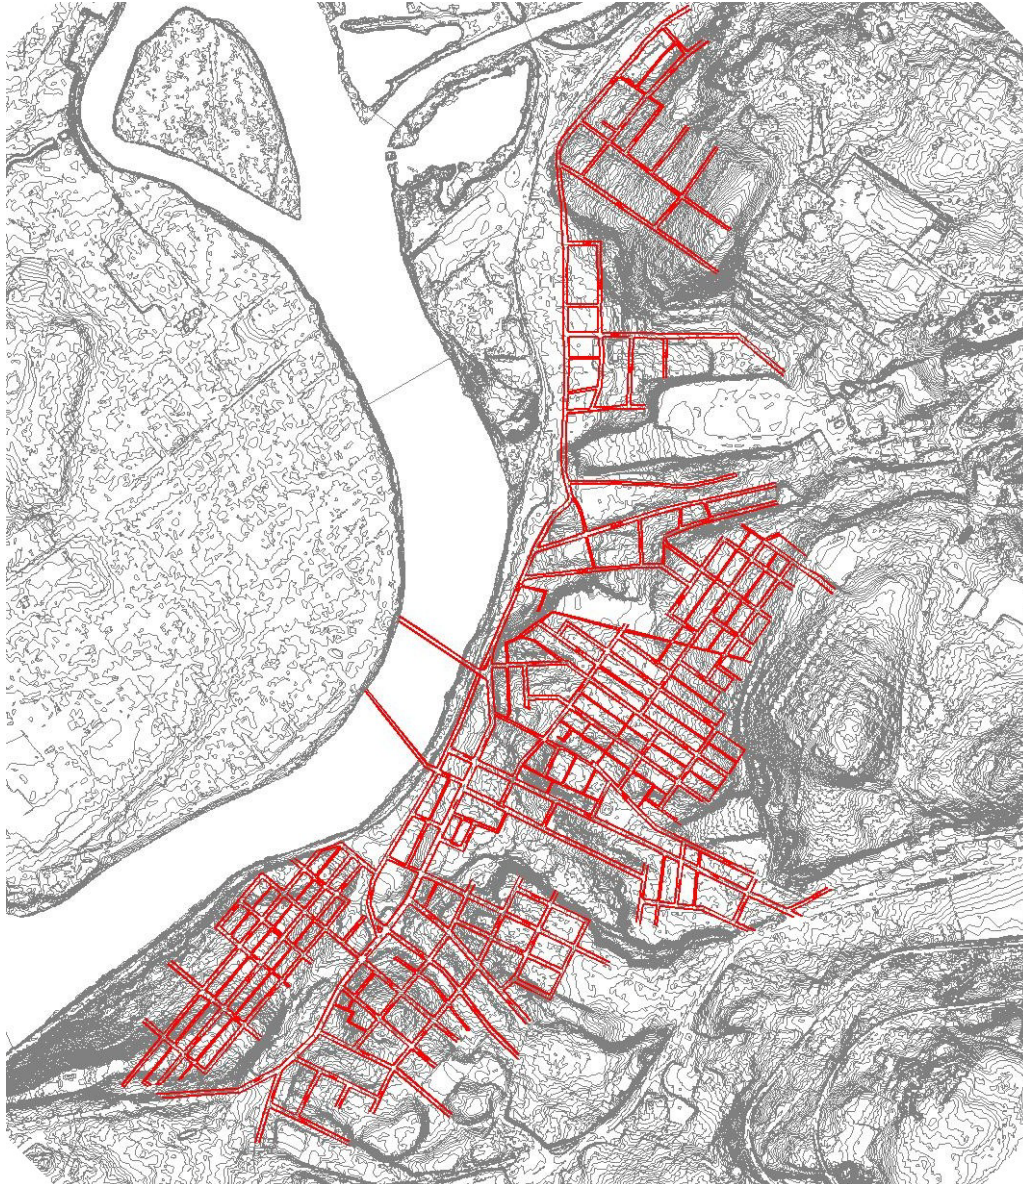
# LiDAR

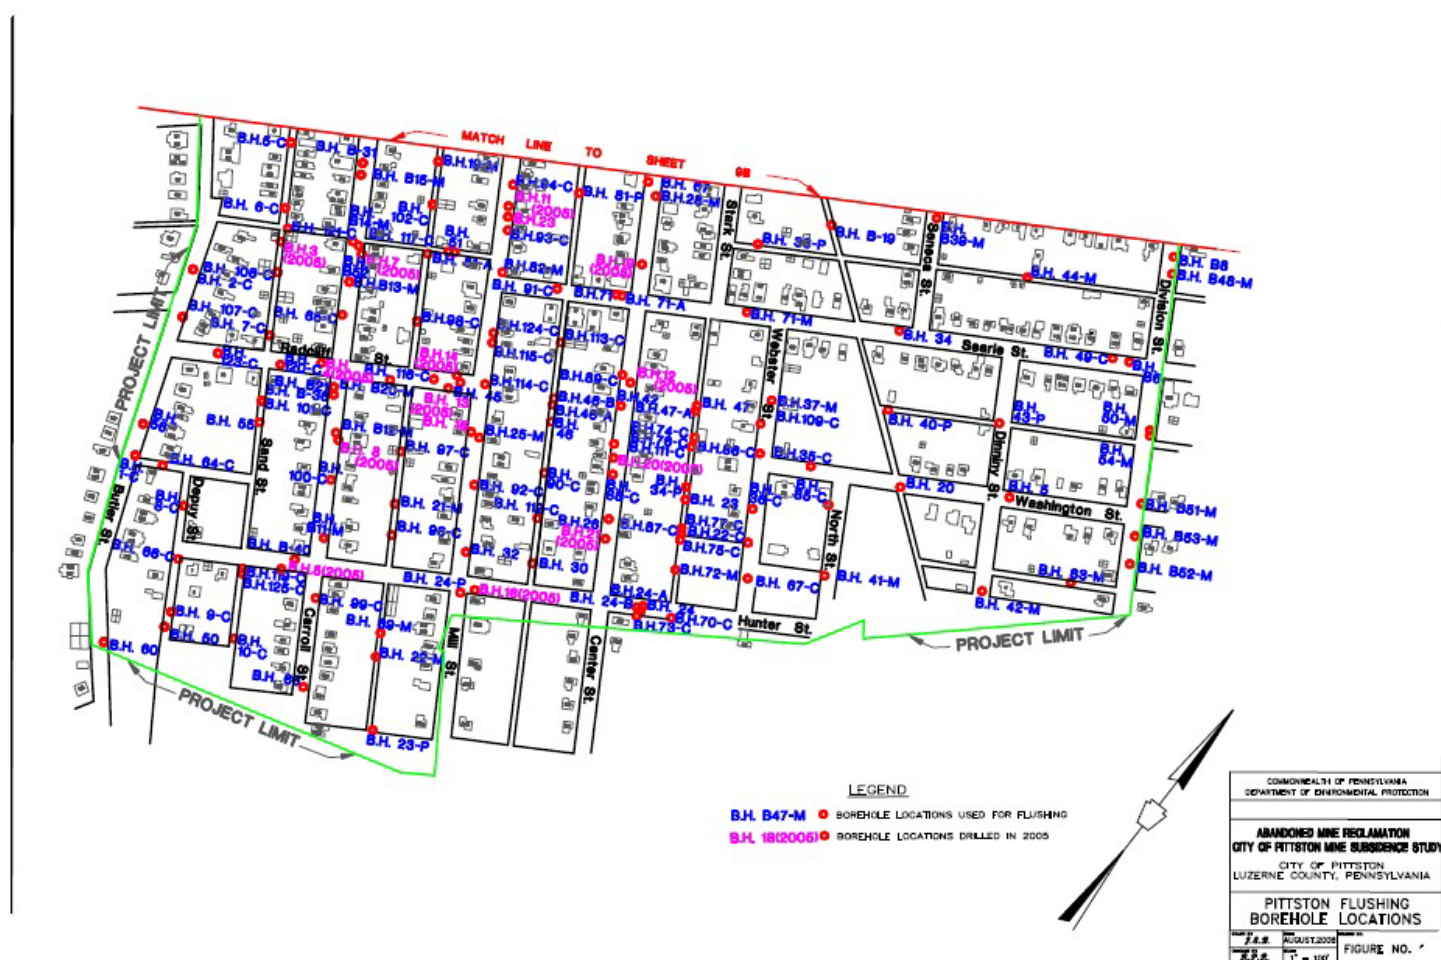
# Drilling and Mine Flushing Data
