Pennsylvania Mine Reclamation Conference August 3, 2012

WHAT IS MINERAL CSA?

AMD Prevention & Remediation

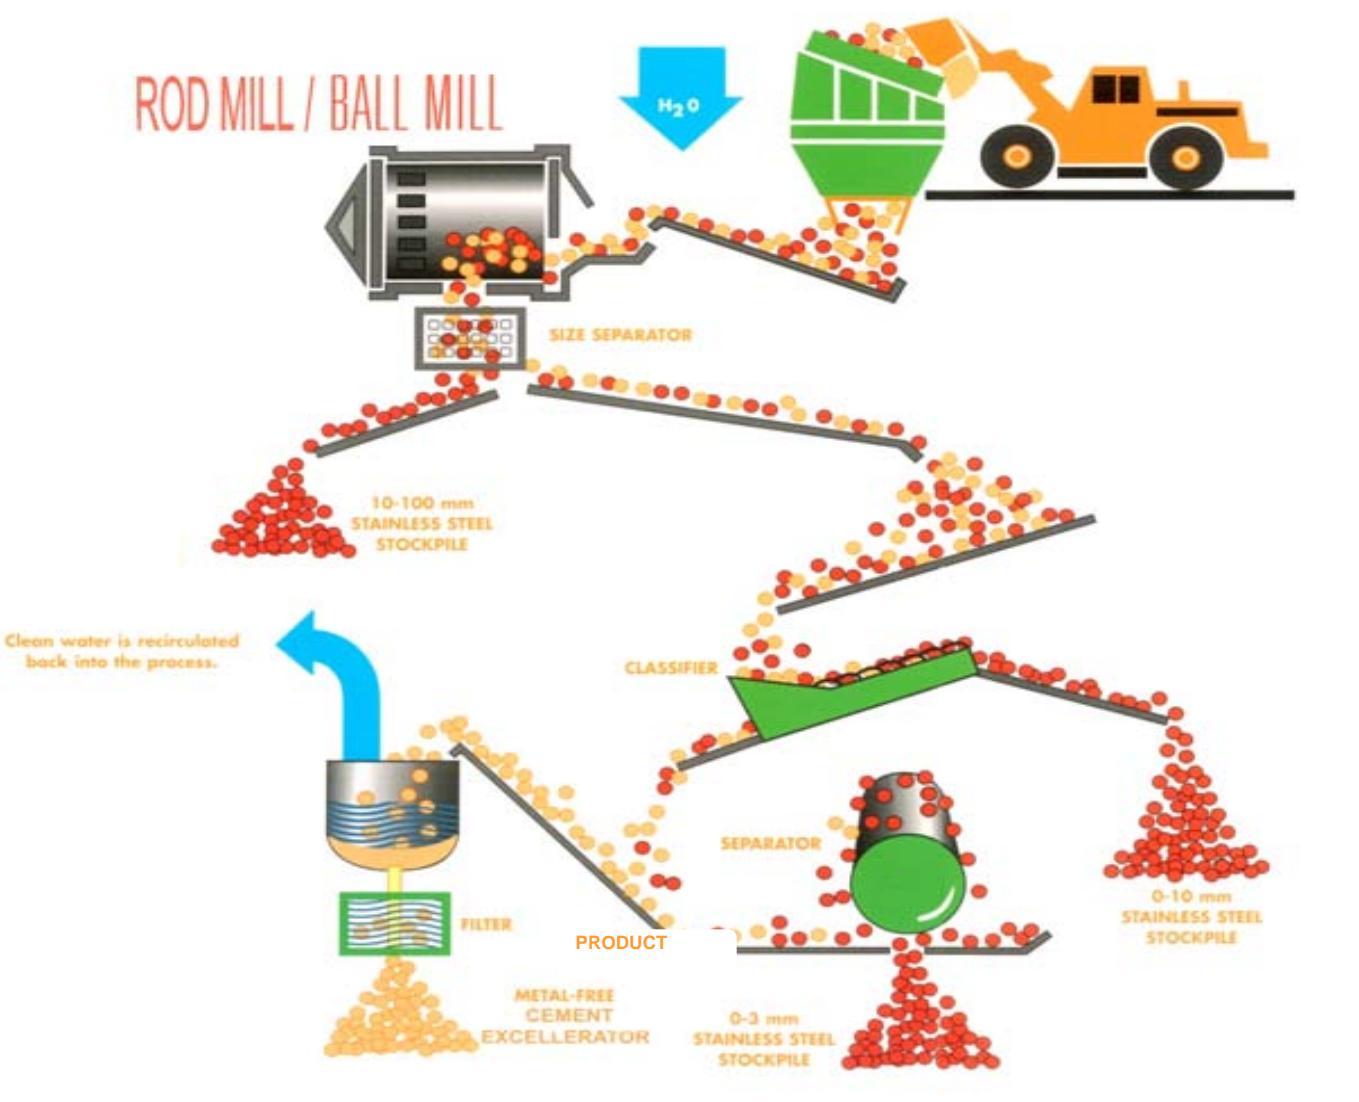
Recycling Process

Material that once raised environmental concerns is now completely and beneficially reused.

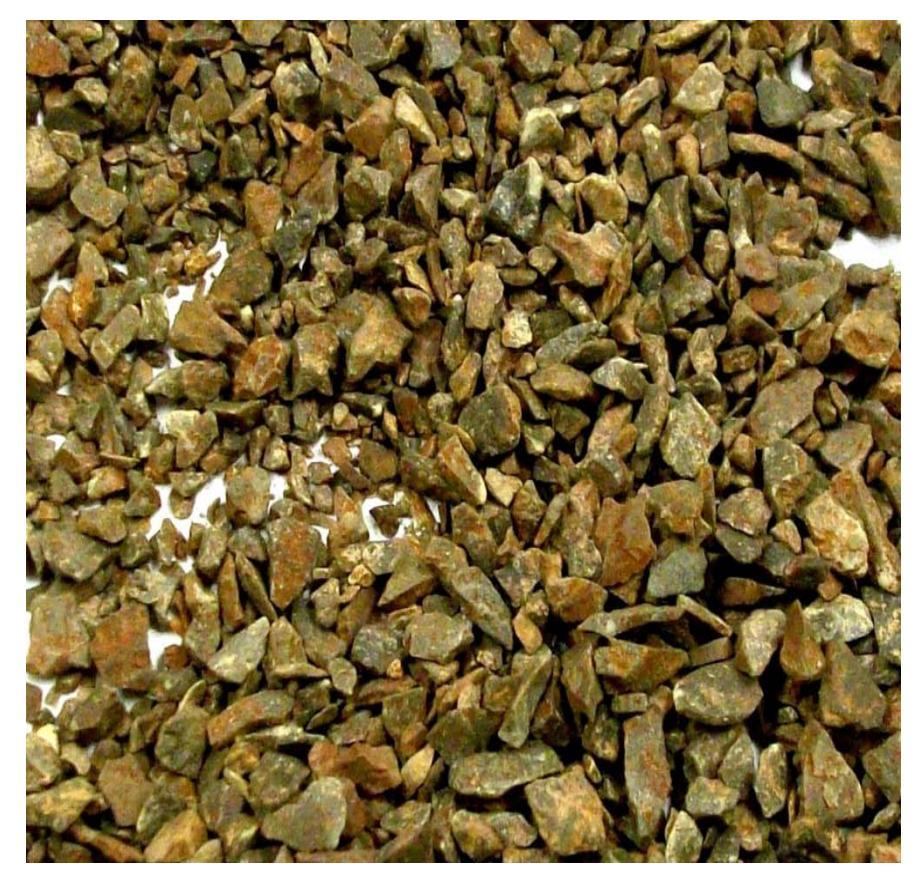
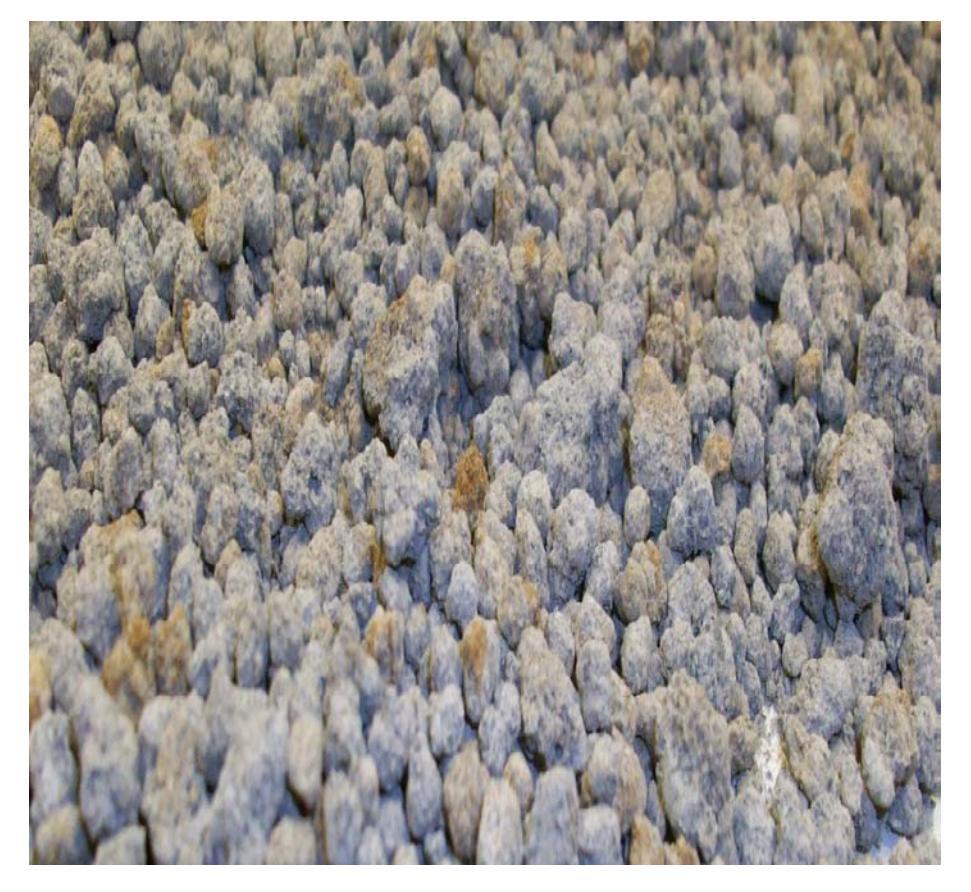
Armored Limestone

Coal Refuse

MINERAL CSA

- Limestone raises the pH and precipitation of metal hydroxides is normally accelerated and the potential of armoring of limestone particles increases significantly.
- Due to its loose crystalline structure and fine gradation, its Relative Neutralizing Value is greater than 86% compared to Agricultural Limestone which is approximately 65%.

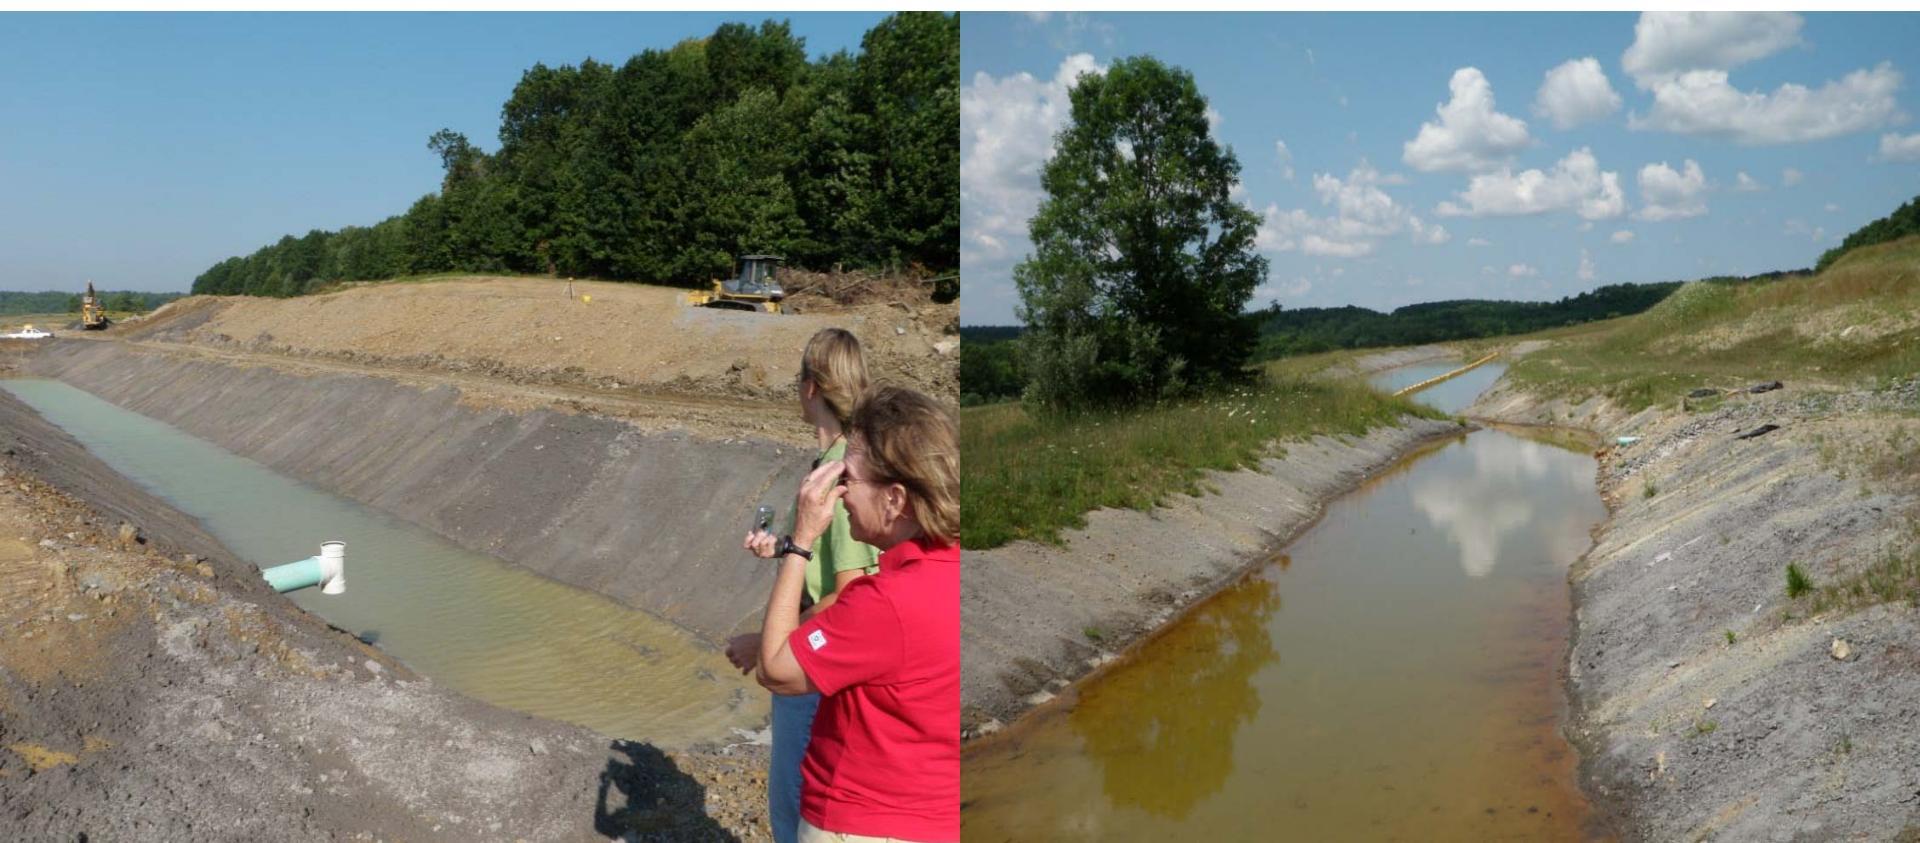
Stream Restoration Inc.

McIntire bond forfeiture mine site needed to treat a highly acidic mine discharge with high concentrations of iron, aluminum, and manganese. The discharge is one of the worst quality discharges in the Slippery Rock Creek Watershed. Mineral CSA is used on this site to line the walls of the settling ponds for alkaline addition.

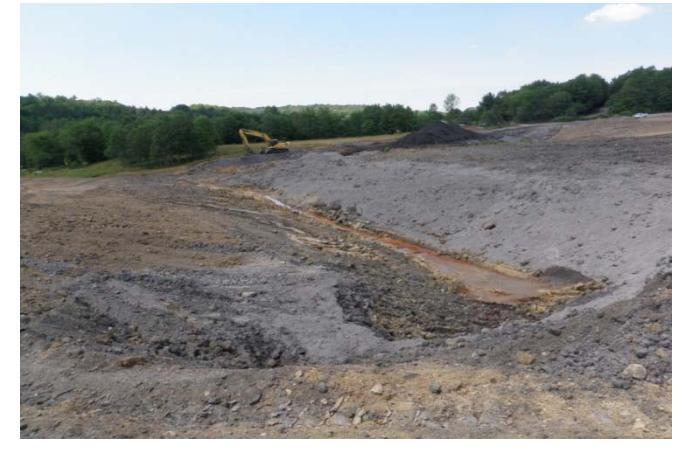
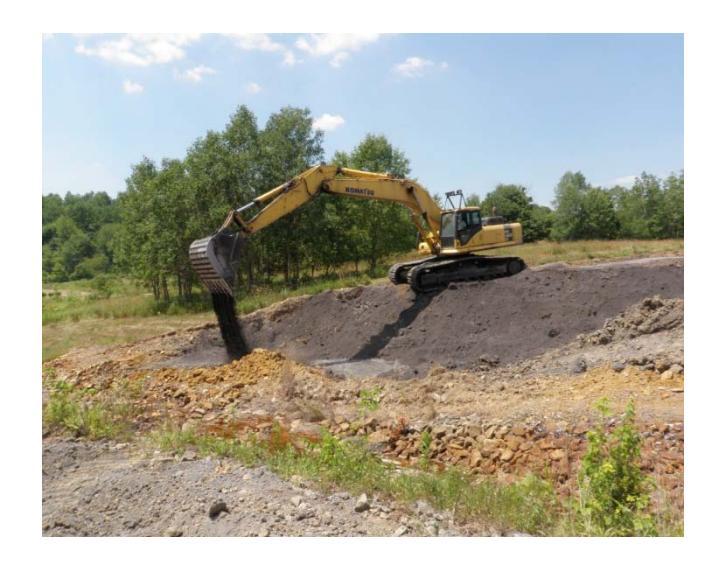
Neal Run Restoration

Mineral CSA was used as an alkaline amendment to help abate the severely degraded drainage issuing from the site.

The project was recently completed and is expected to prevent over 100,000 lbs. (50 tons) of metals and nearly 400,000 lbs. (200 tons) of acidity every year from entering Neal Run

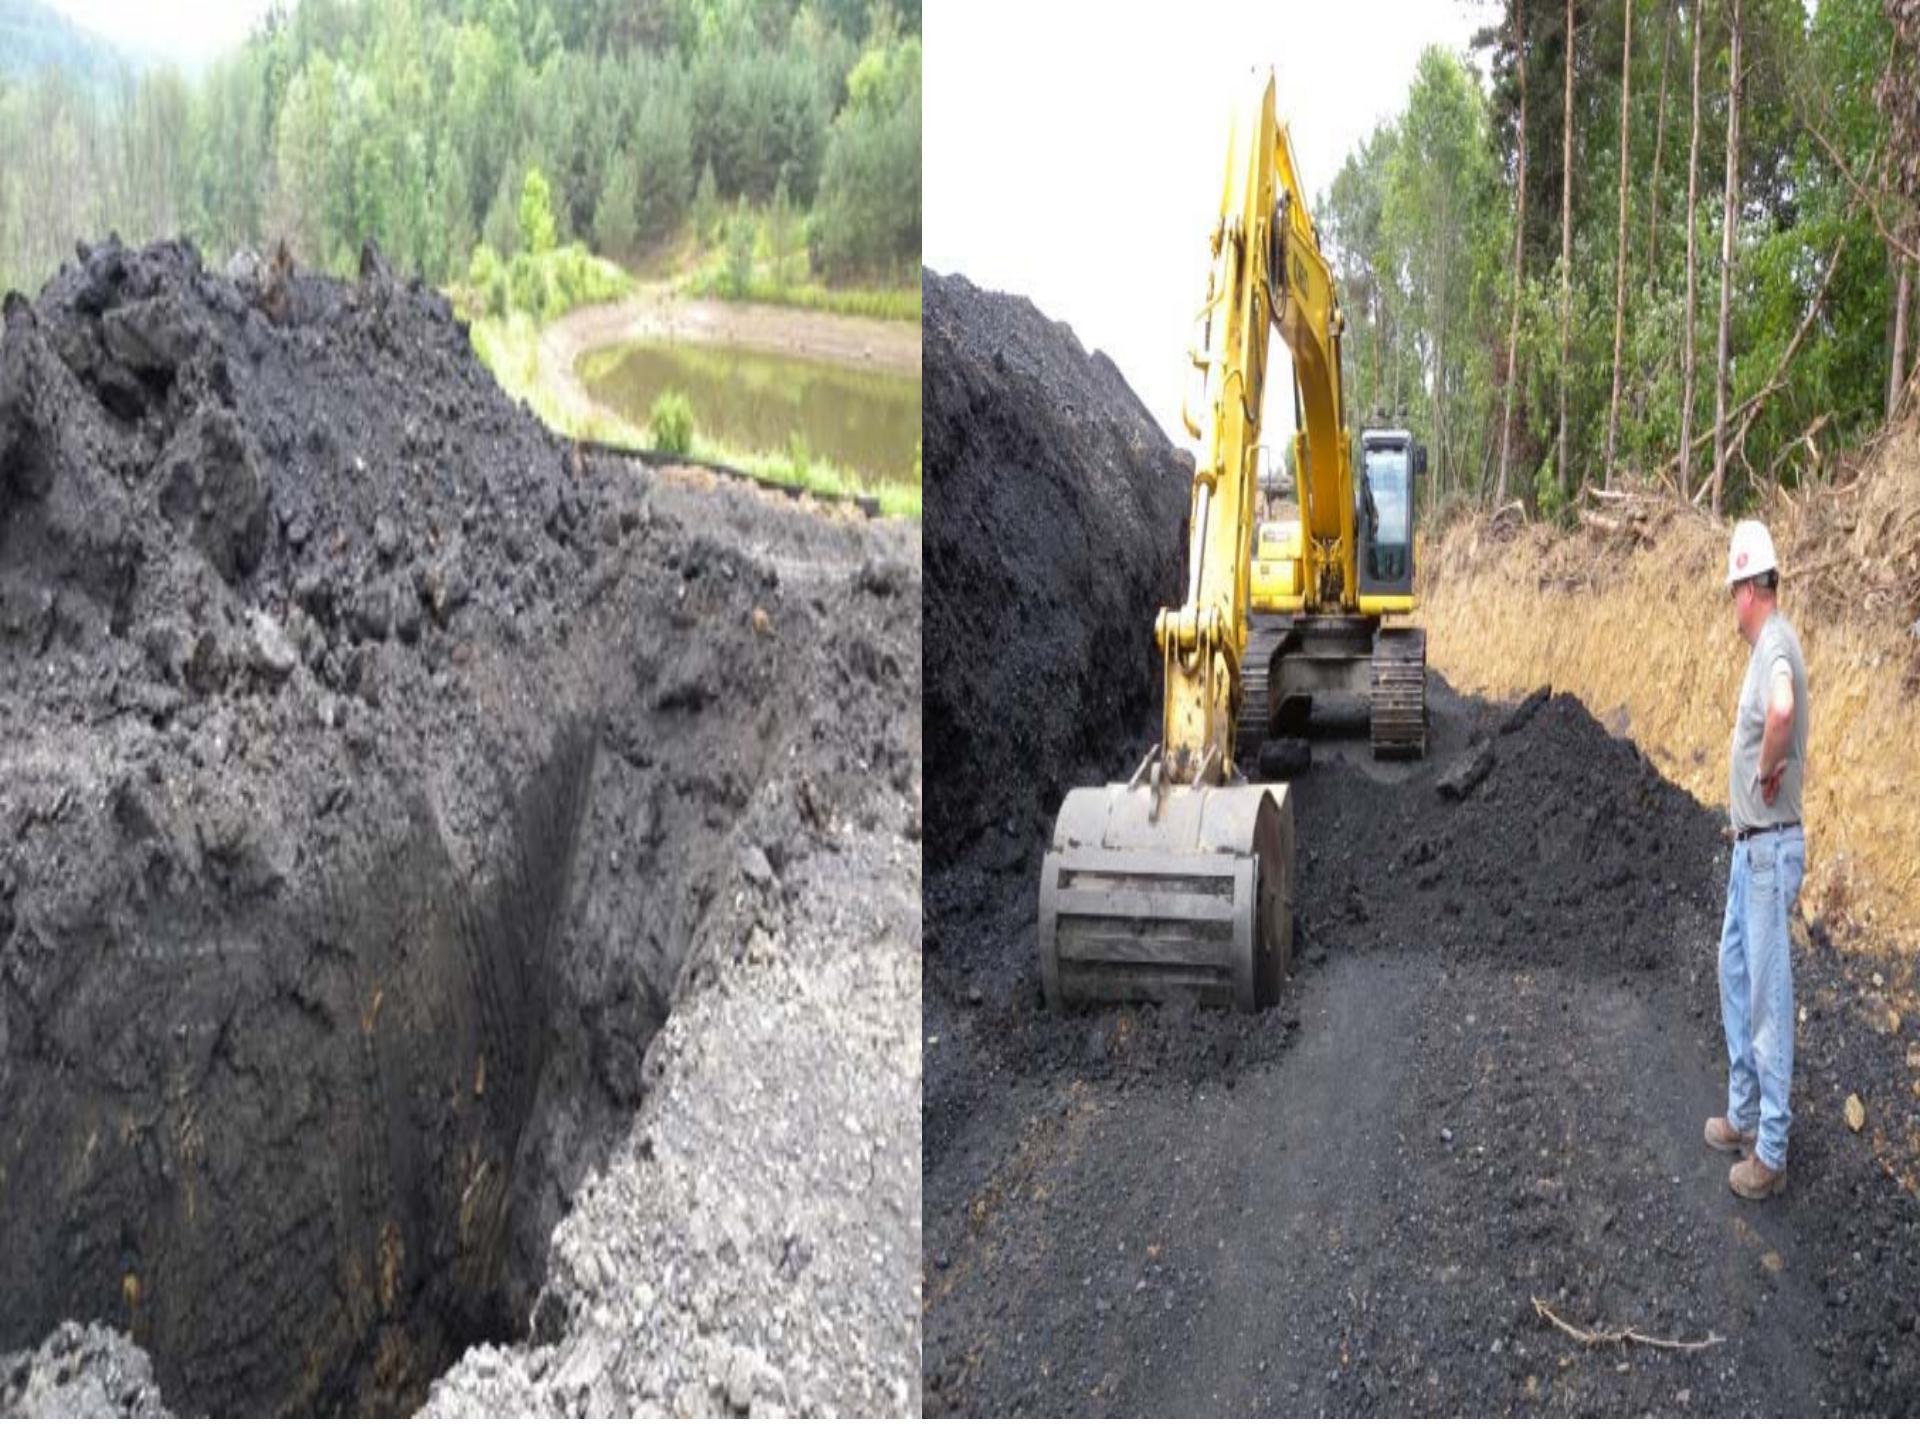
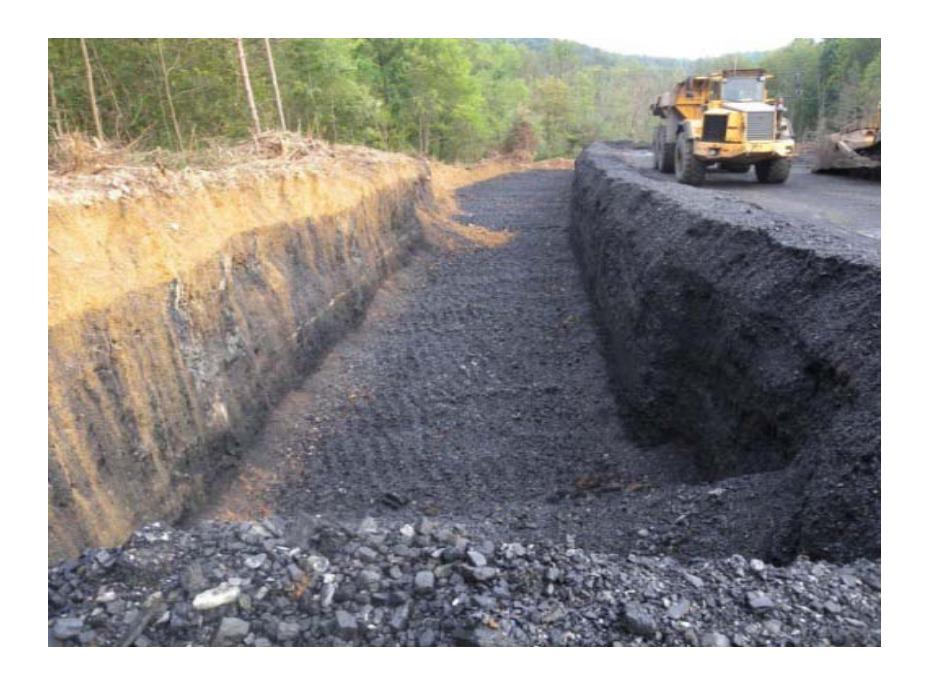
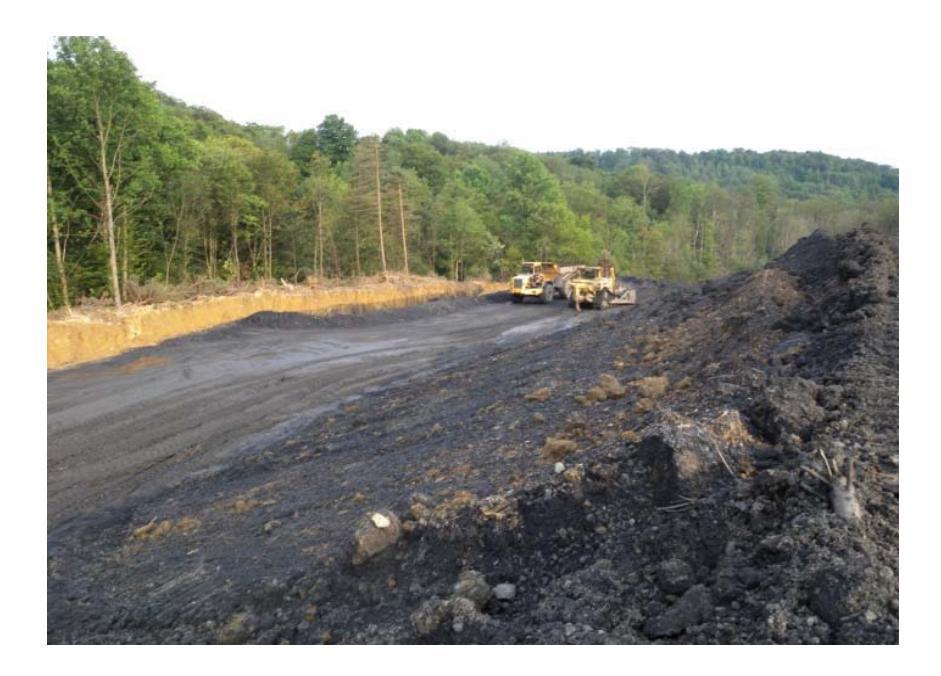
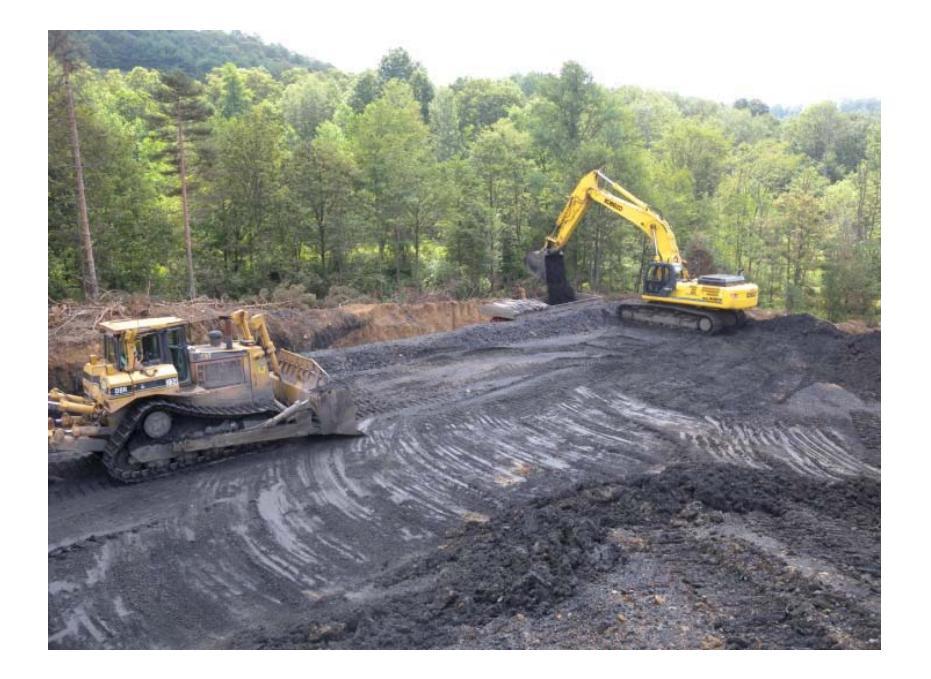
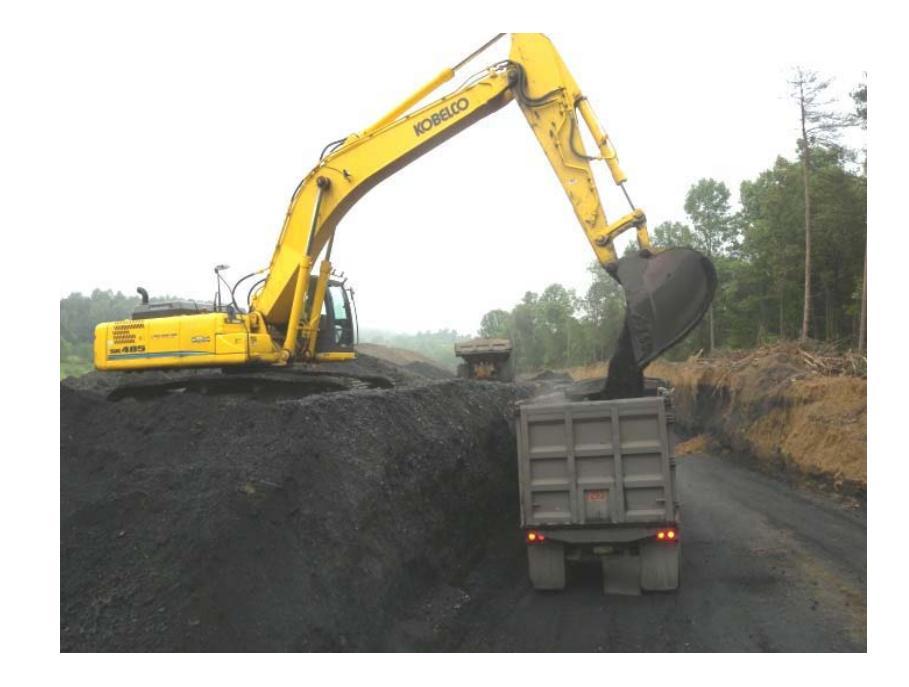
Removal and special handling of coal refuse to reduce the impact of degraded drainage in the Reeds Run Watershed

Mineral CSA (Harsco Minerals) used for temporary treatment of degraded water from the coal refuse pile and used as an alkaline amendment during reclamation

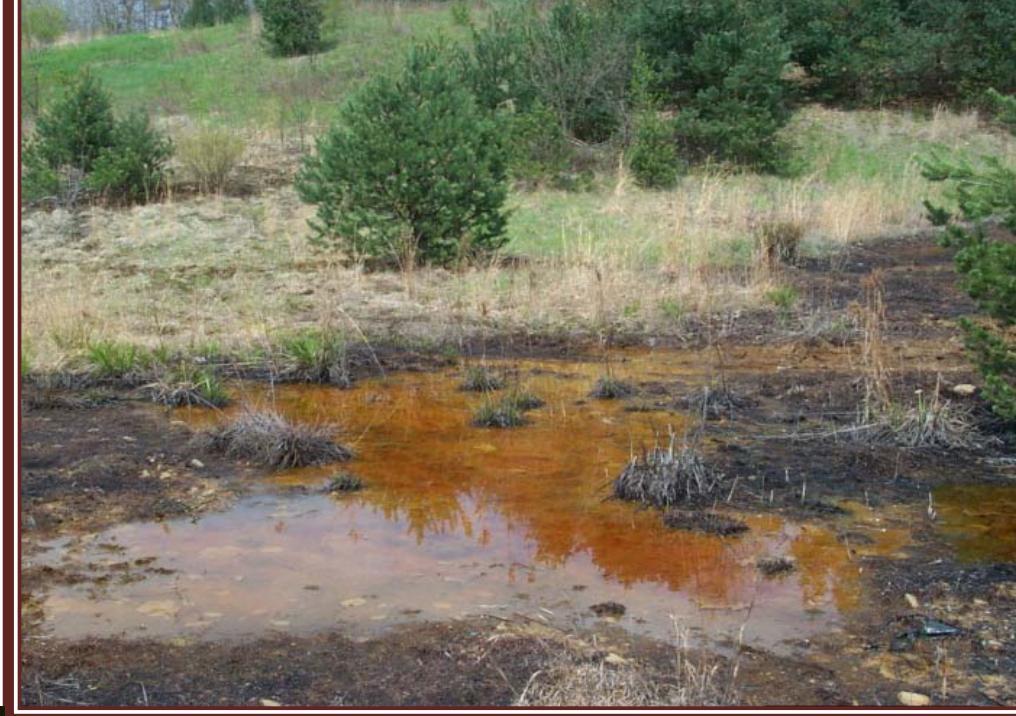
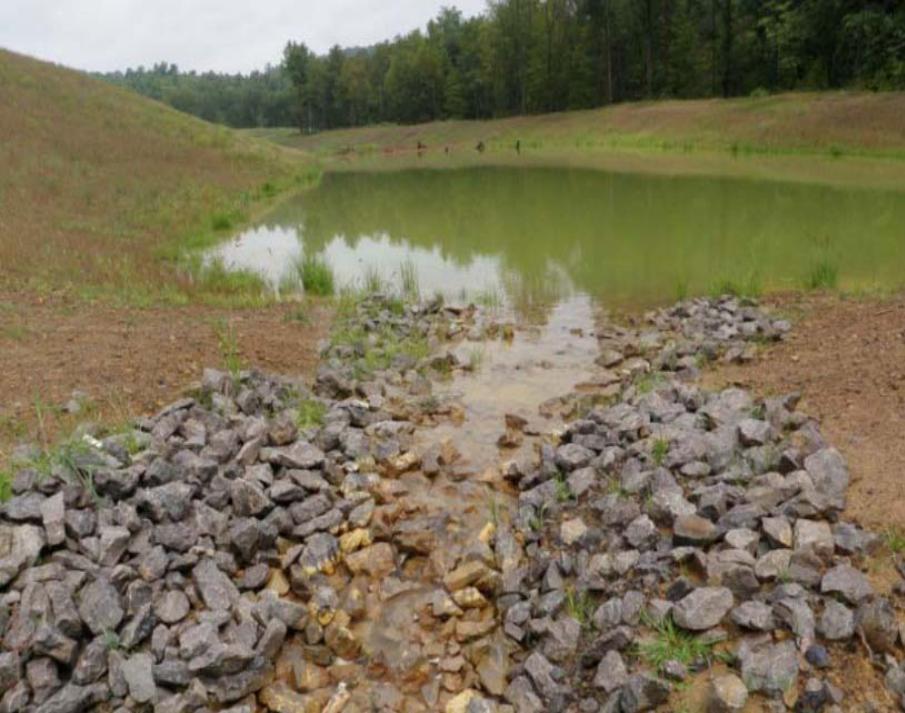
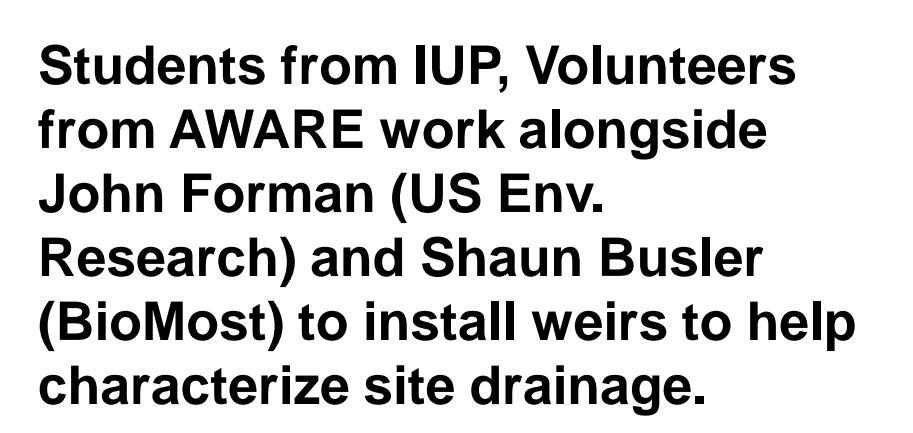
Reeds Run AMD Remediation Project

Wetlands were heavily impacted by degraded drainage of the coal refuse.

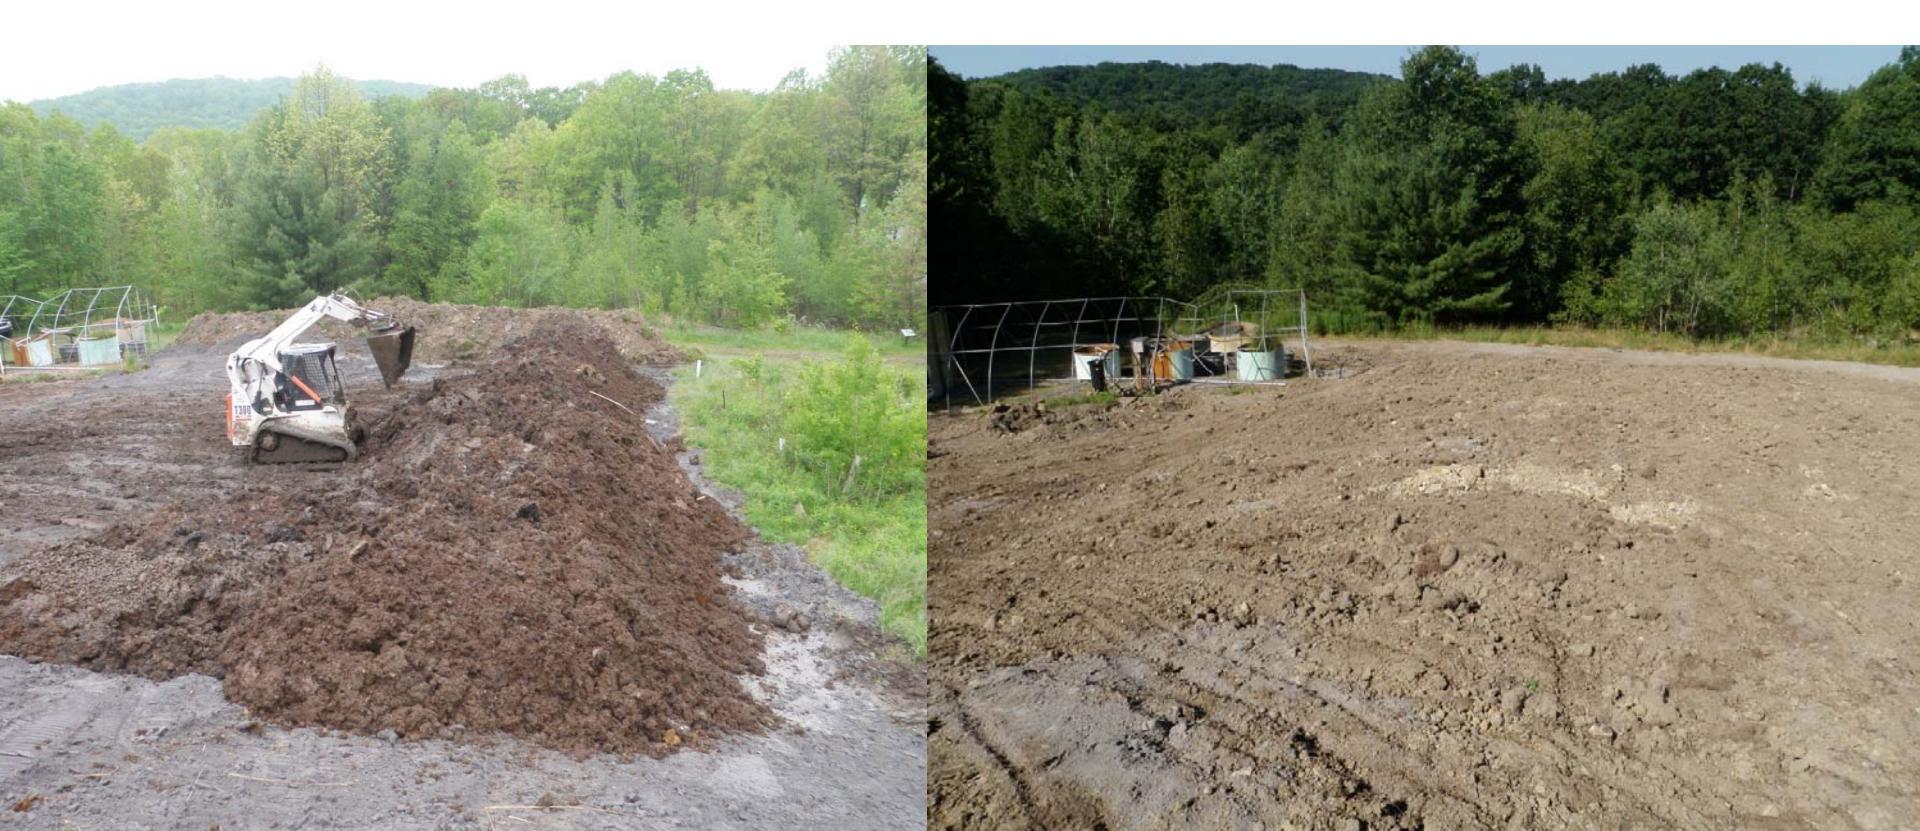
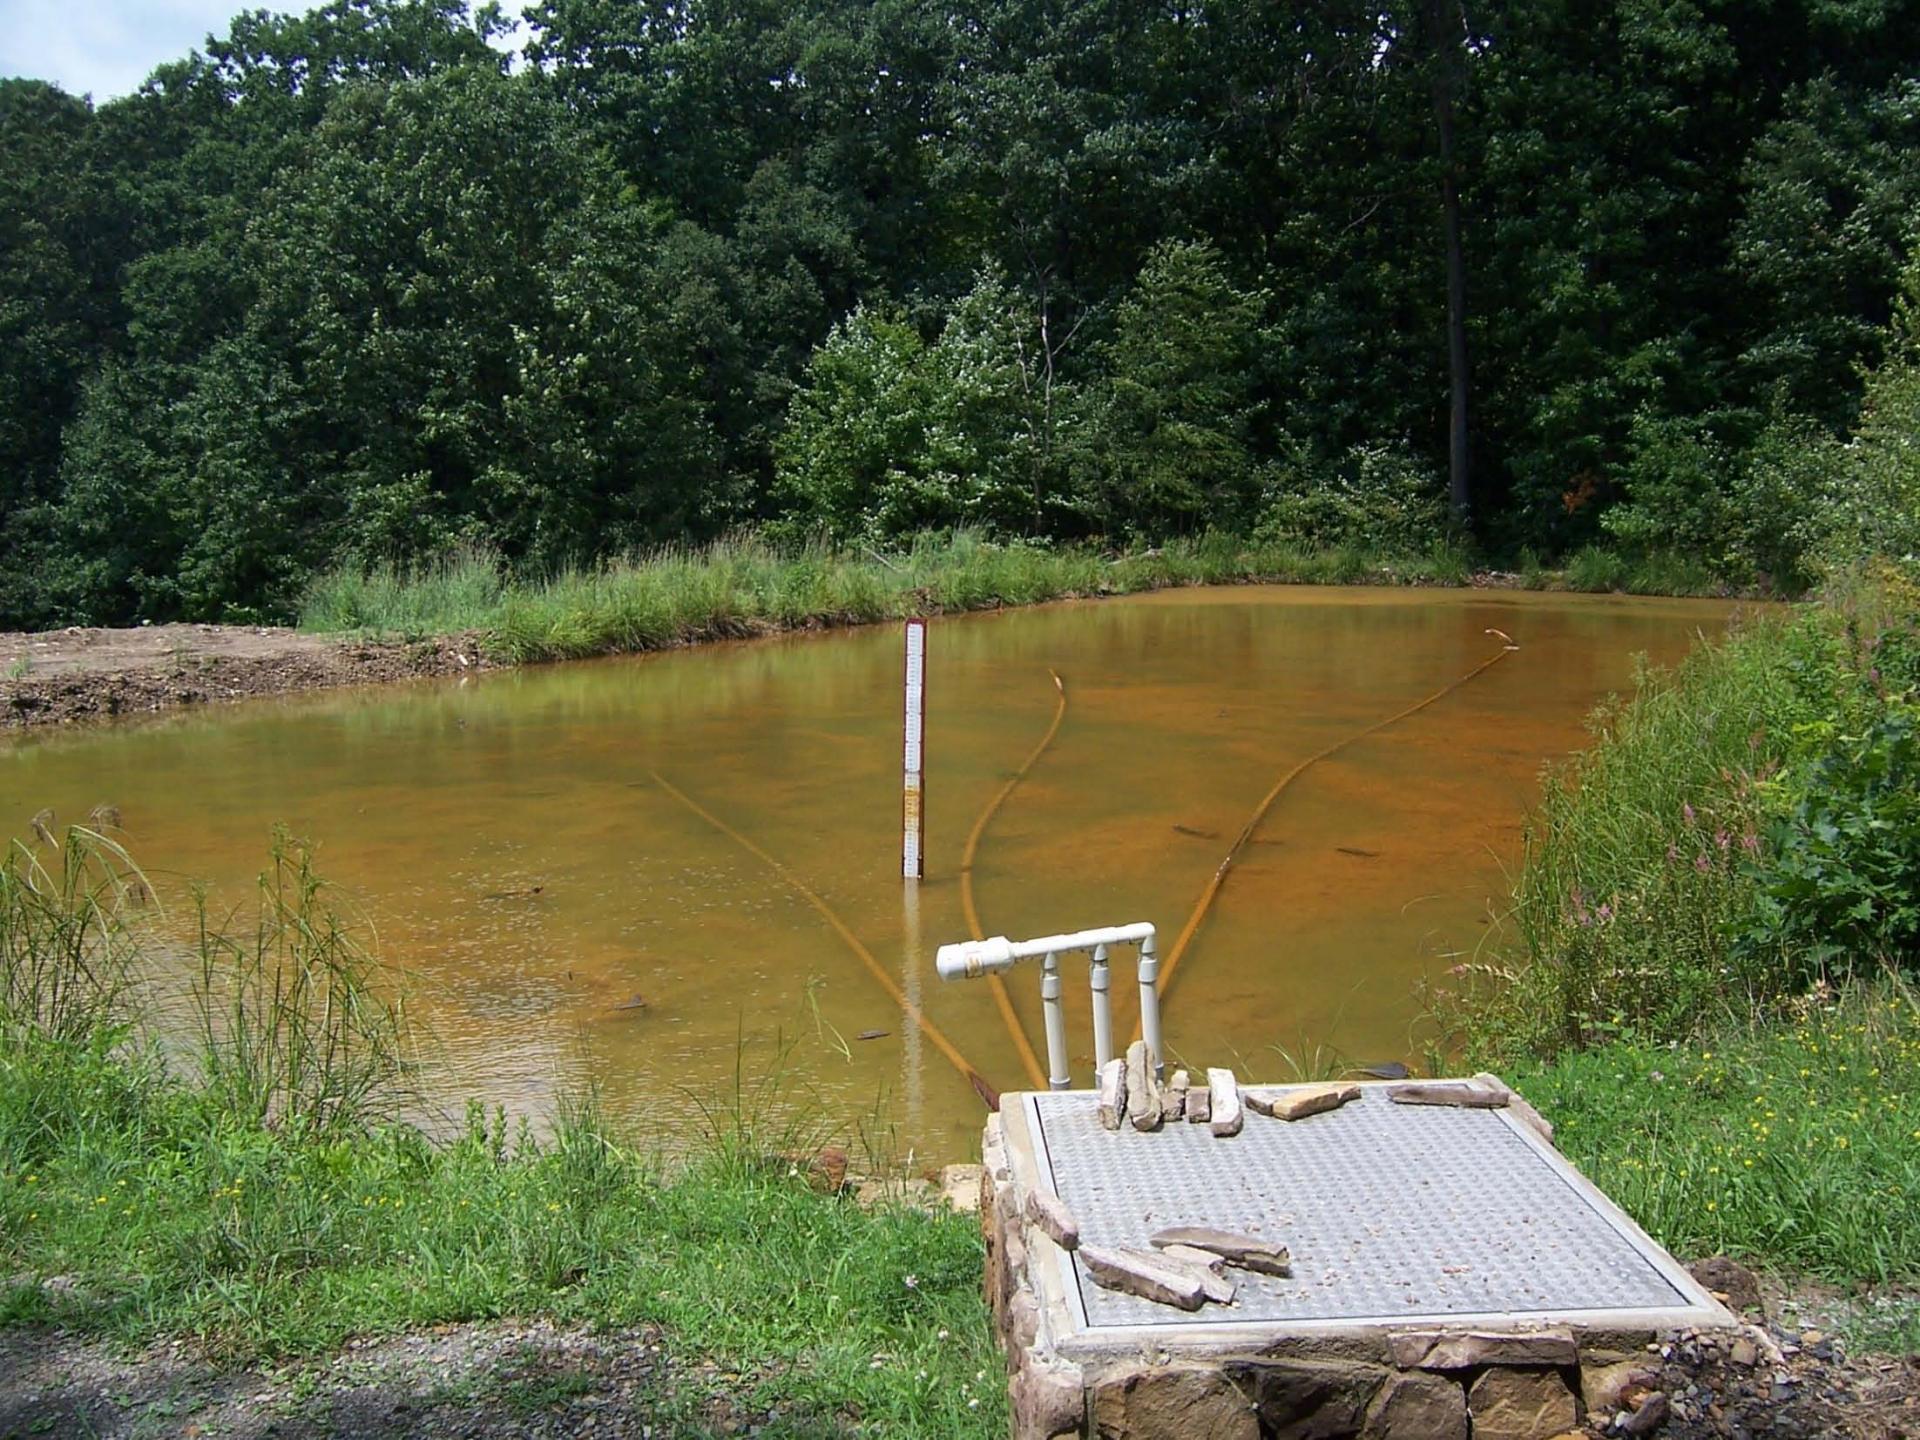
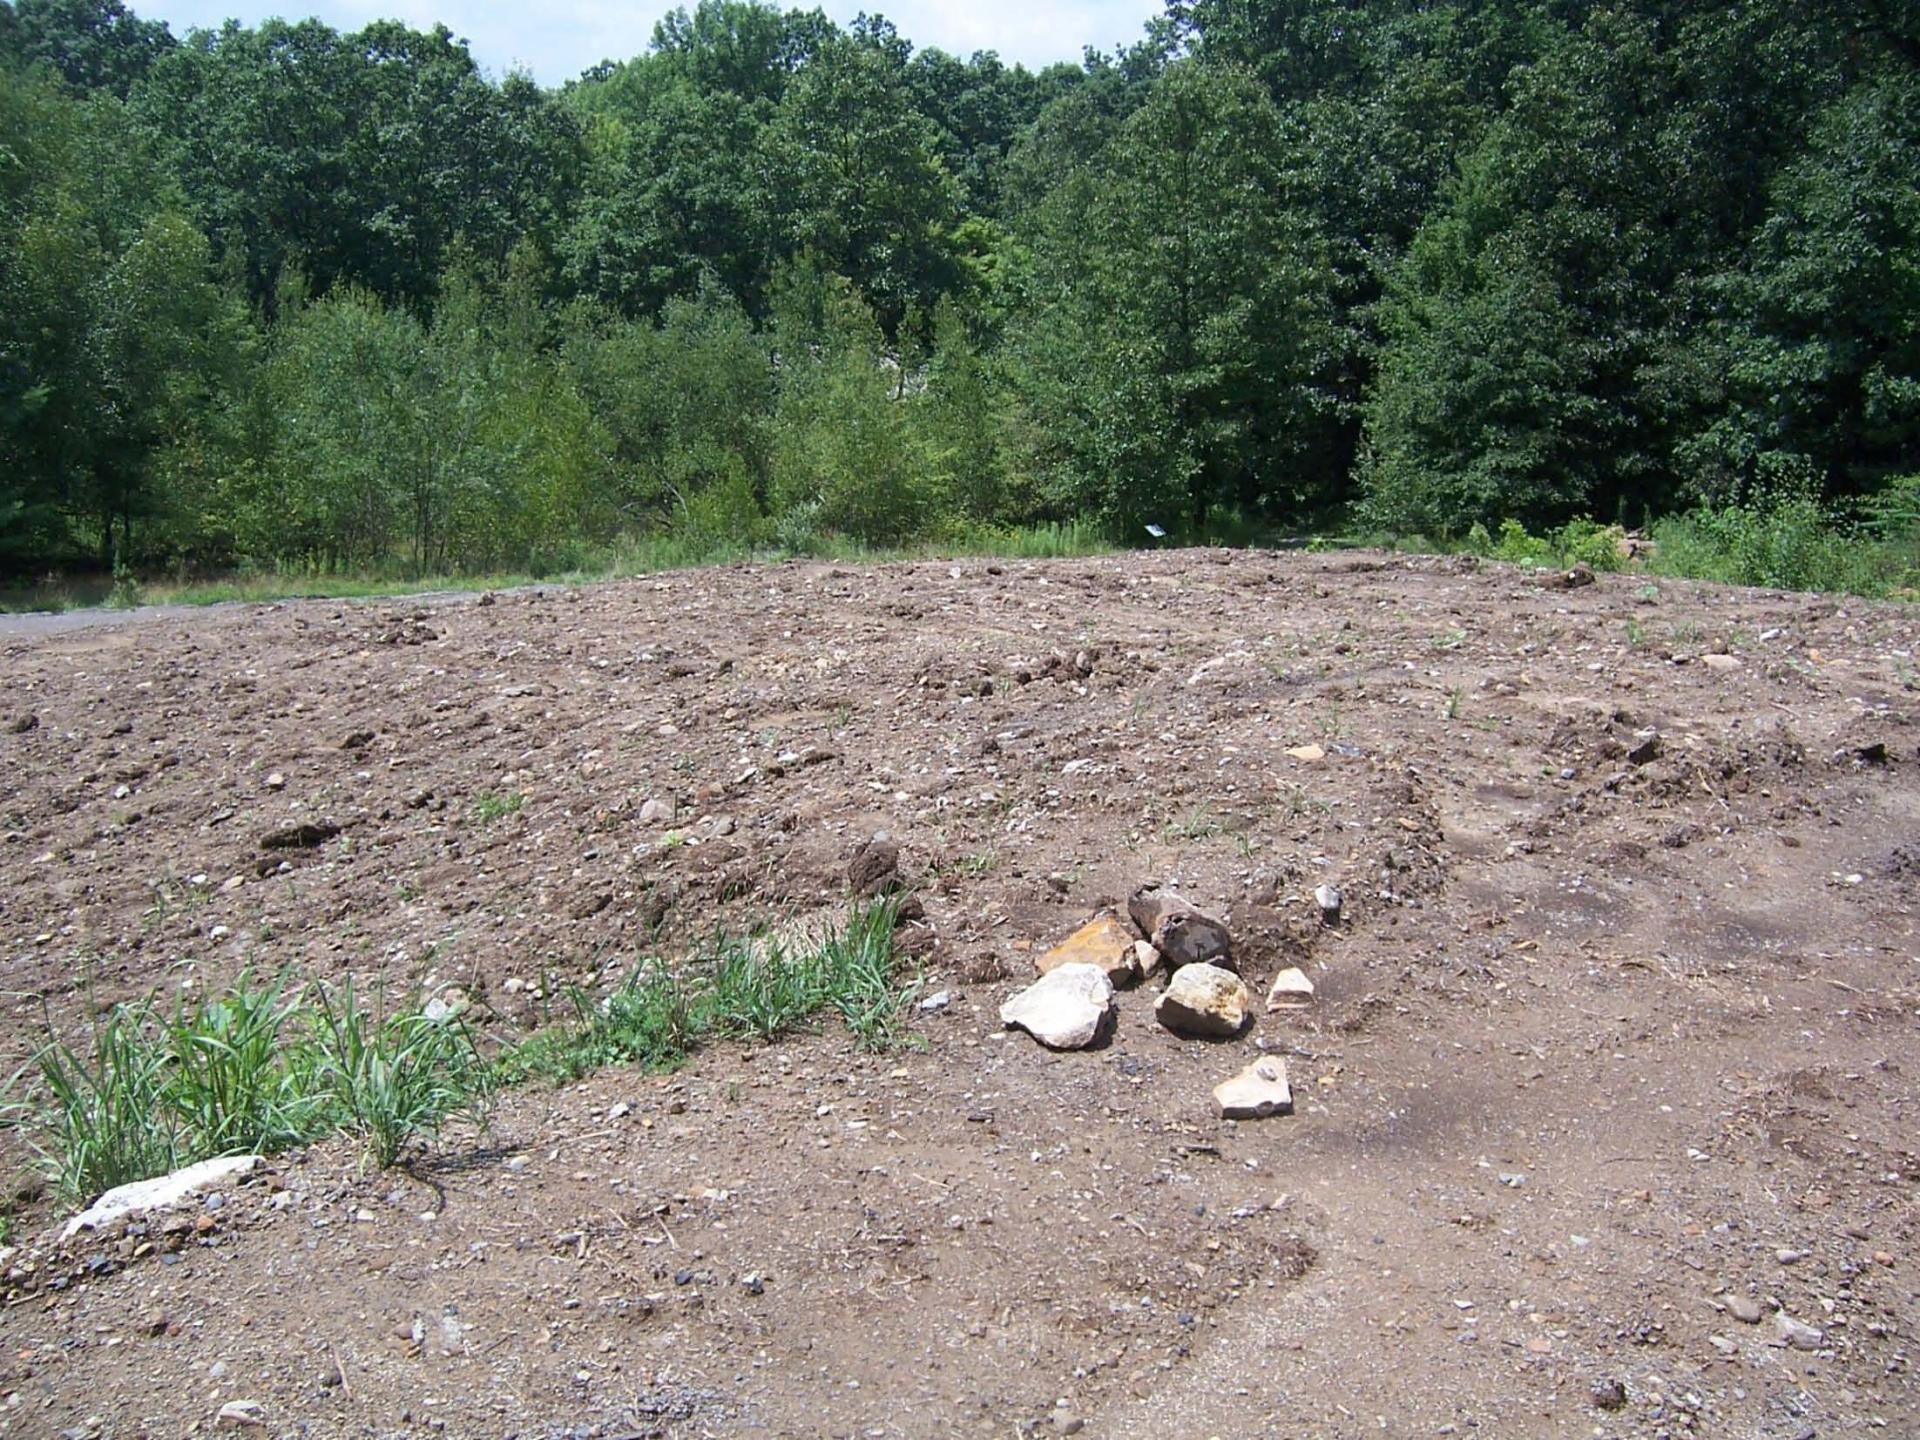
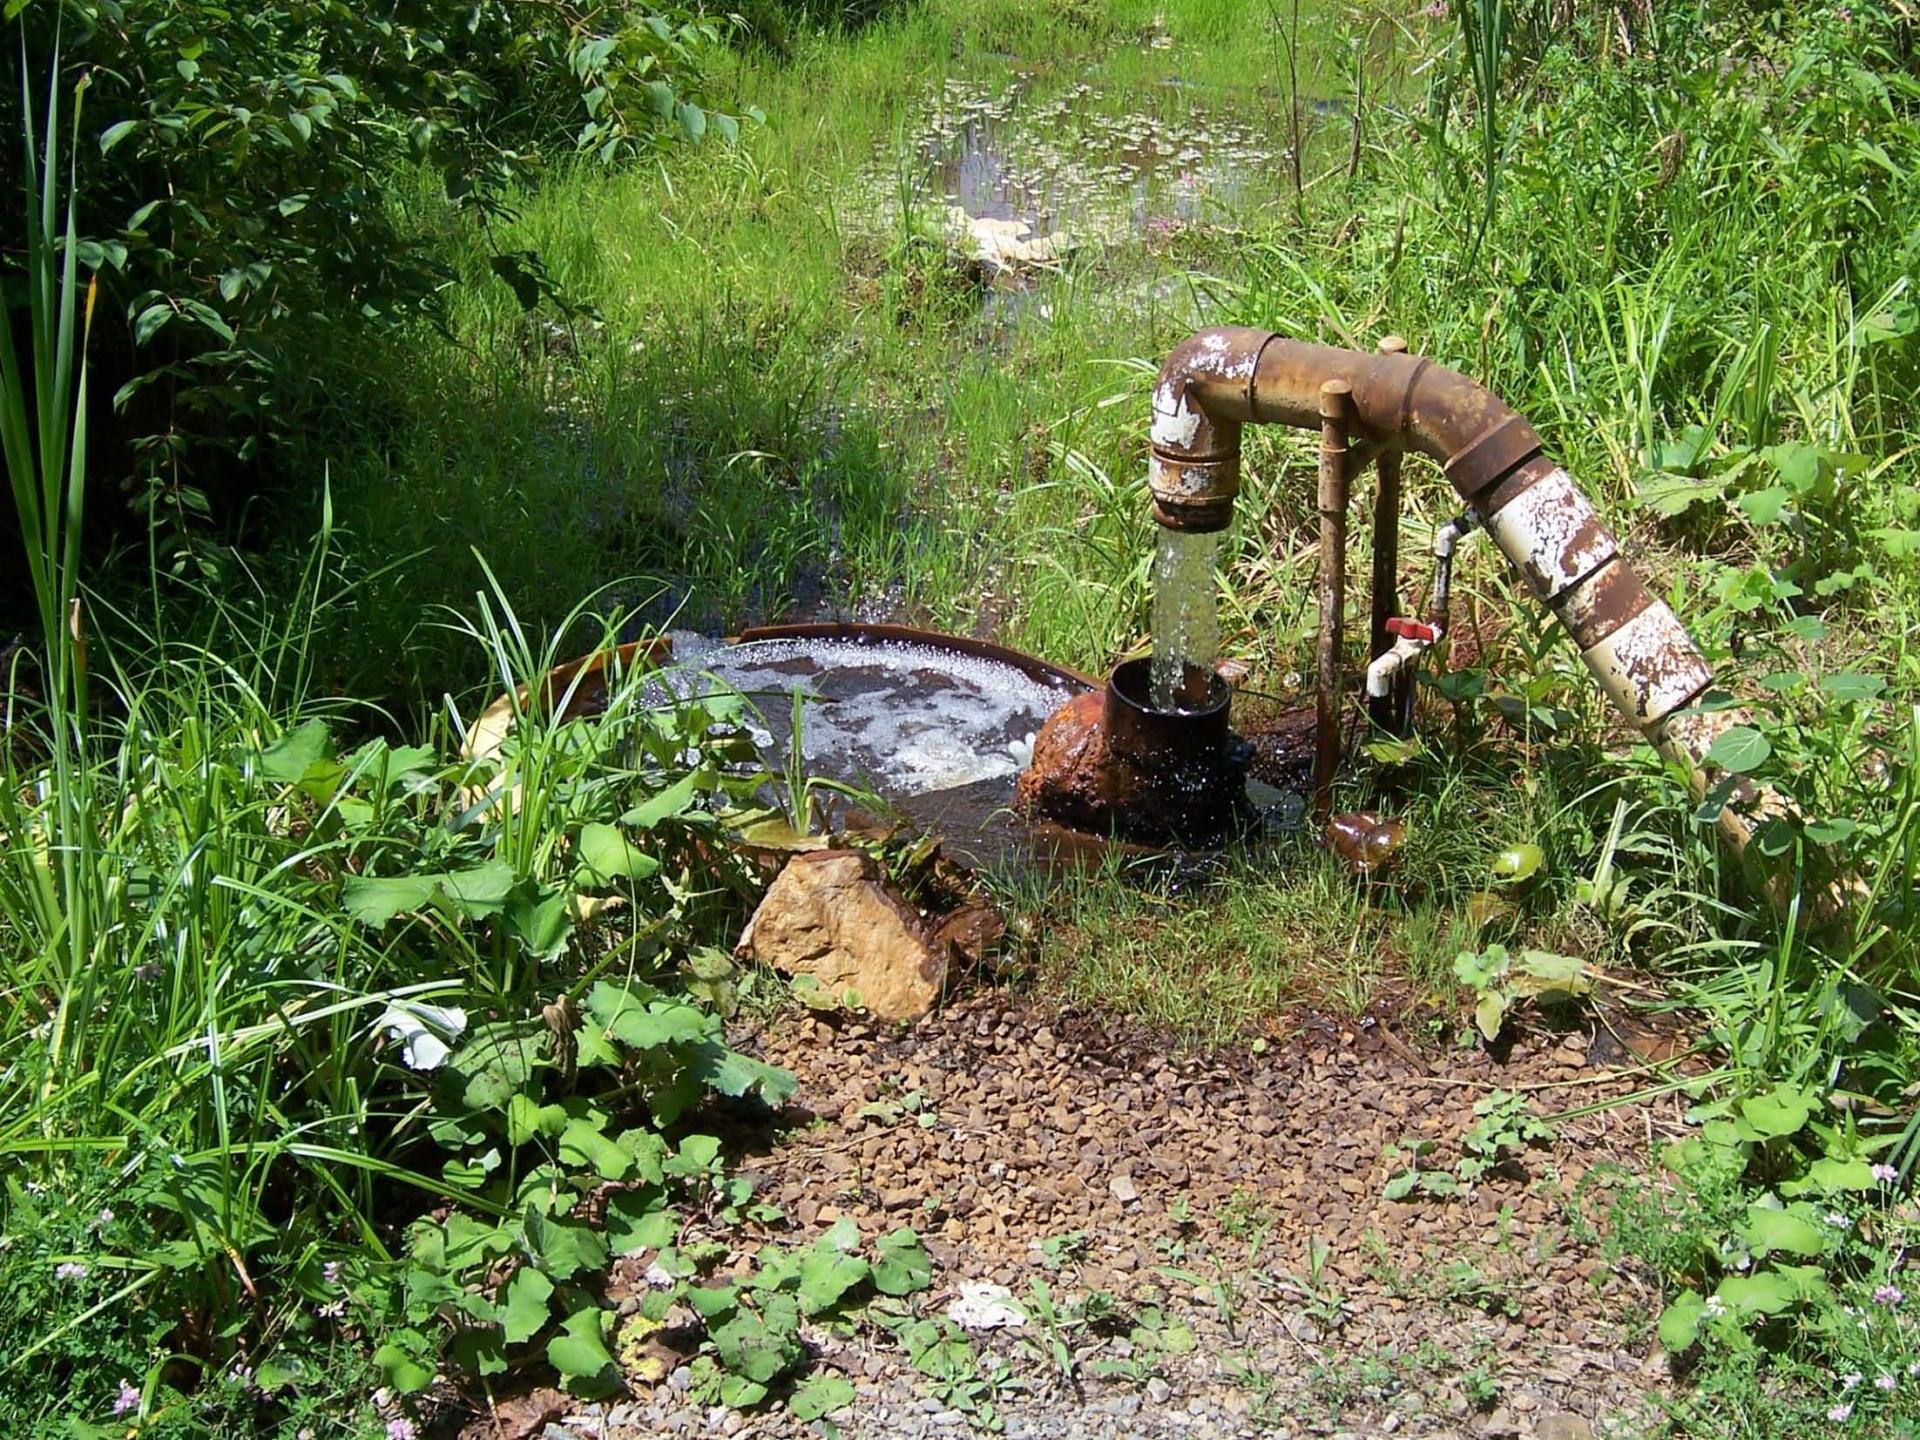
Jennings Environmental Education Center is located near Slippery Rock, PA. The site here is used as a place to teach people of all ages about abandoned mine drainage and the many ways that it can be treated. There is a Vertical Flow Pond on site that was recently re-done after a longer-than-expected life of 15 years. Mineral CSA was used on this site to encapsulate the removed, old mixture of spent mushroom compost and limestone.
