Pennsylvania Mine Reclamation Conference August 3, 2012

WHAT IS MINERAL CSA?

AMD Prevention & Remediation

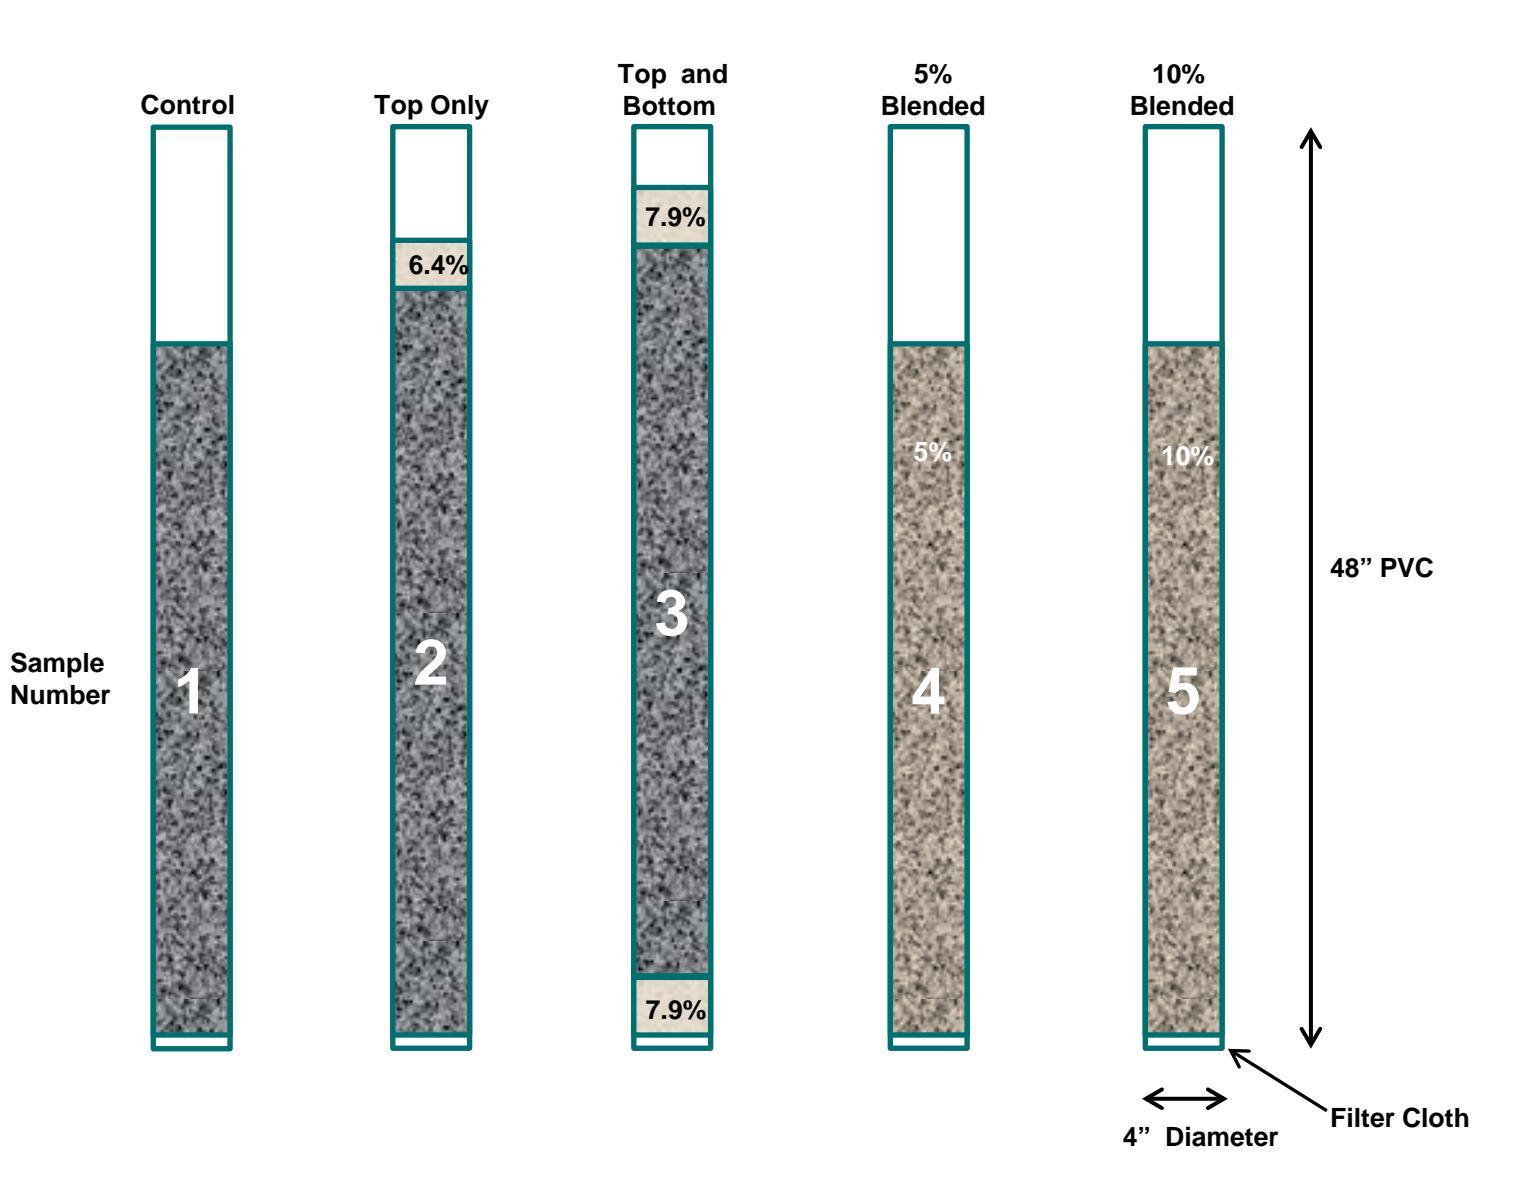
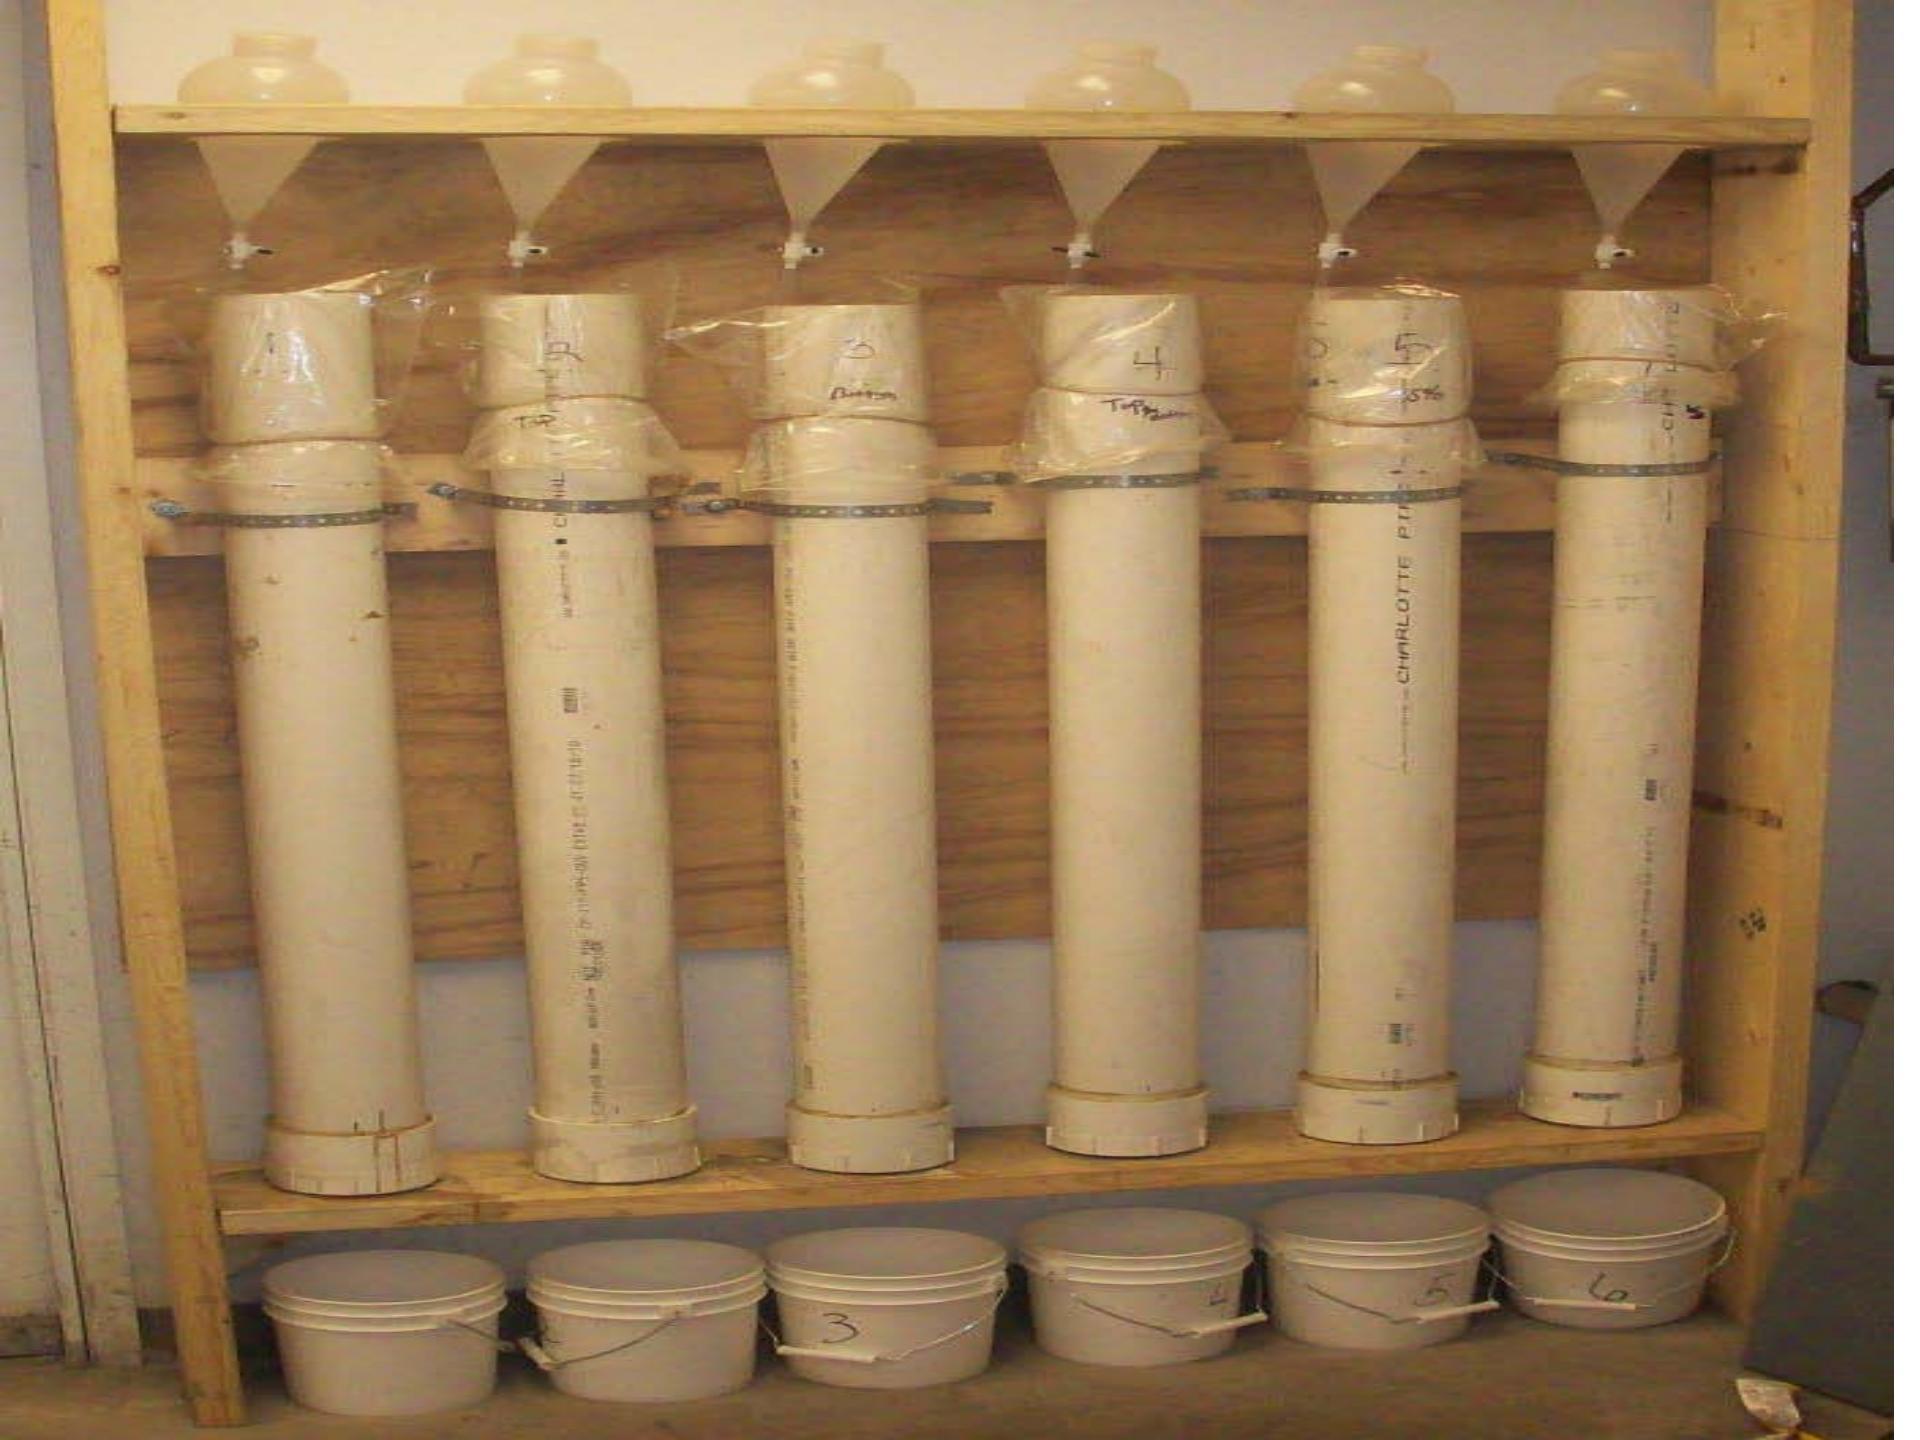
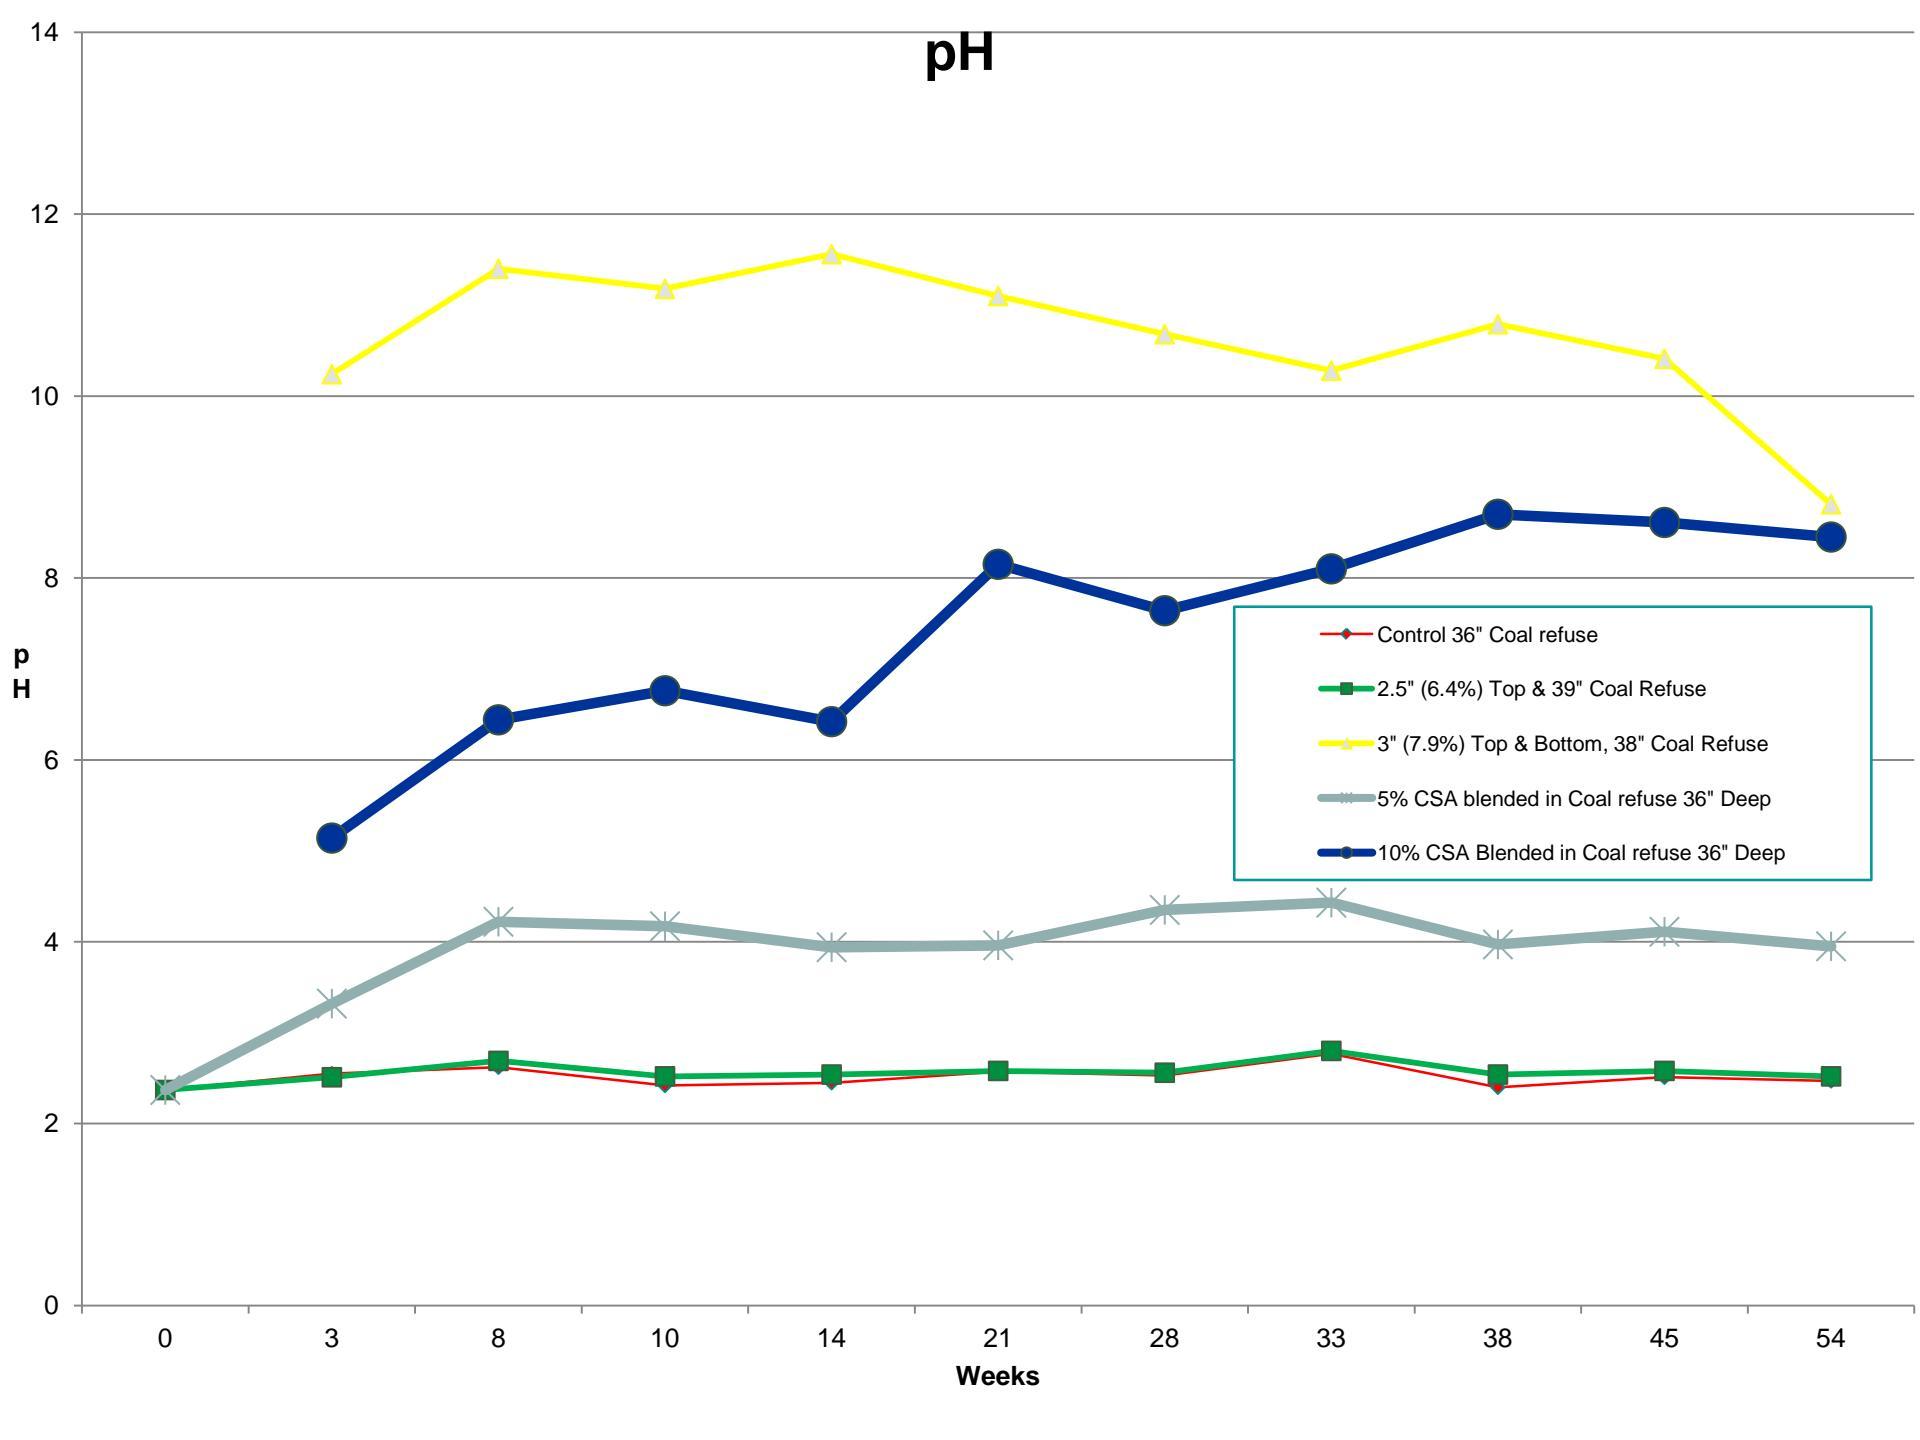
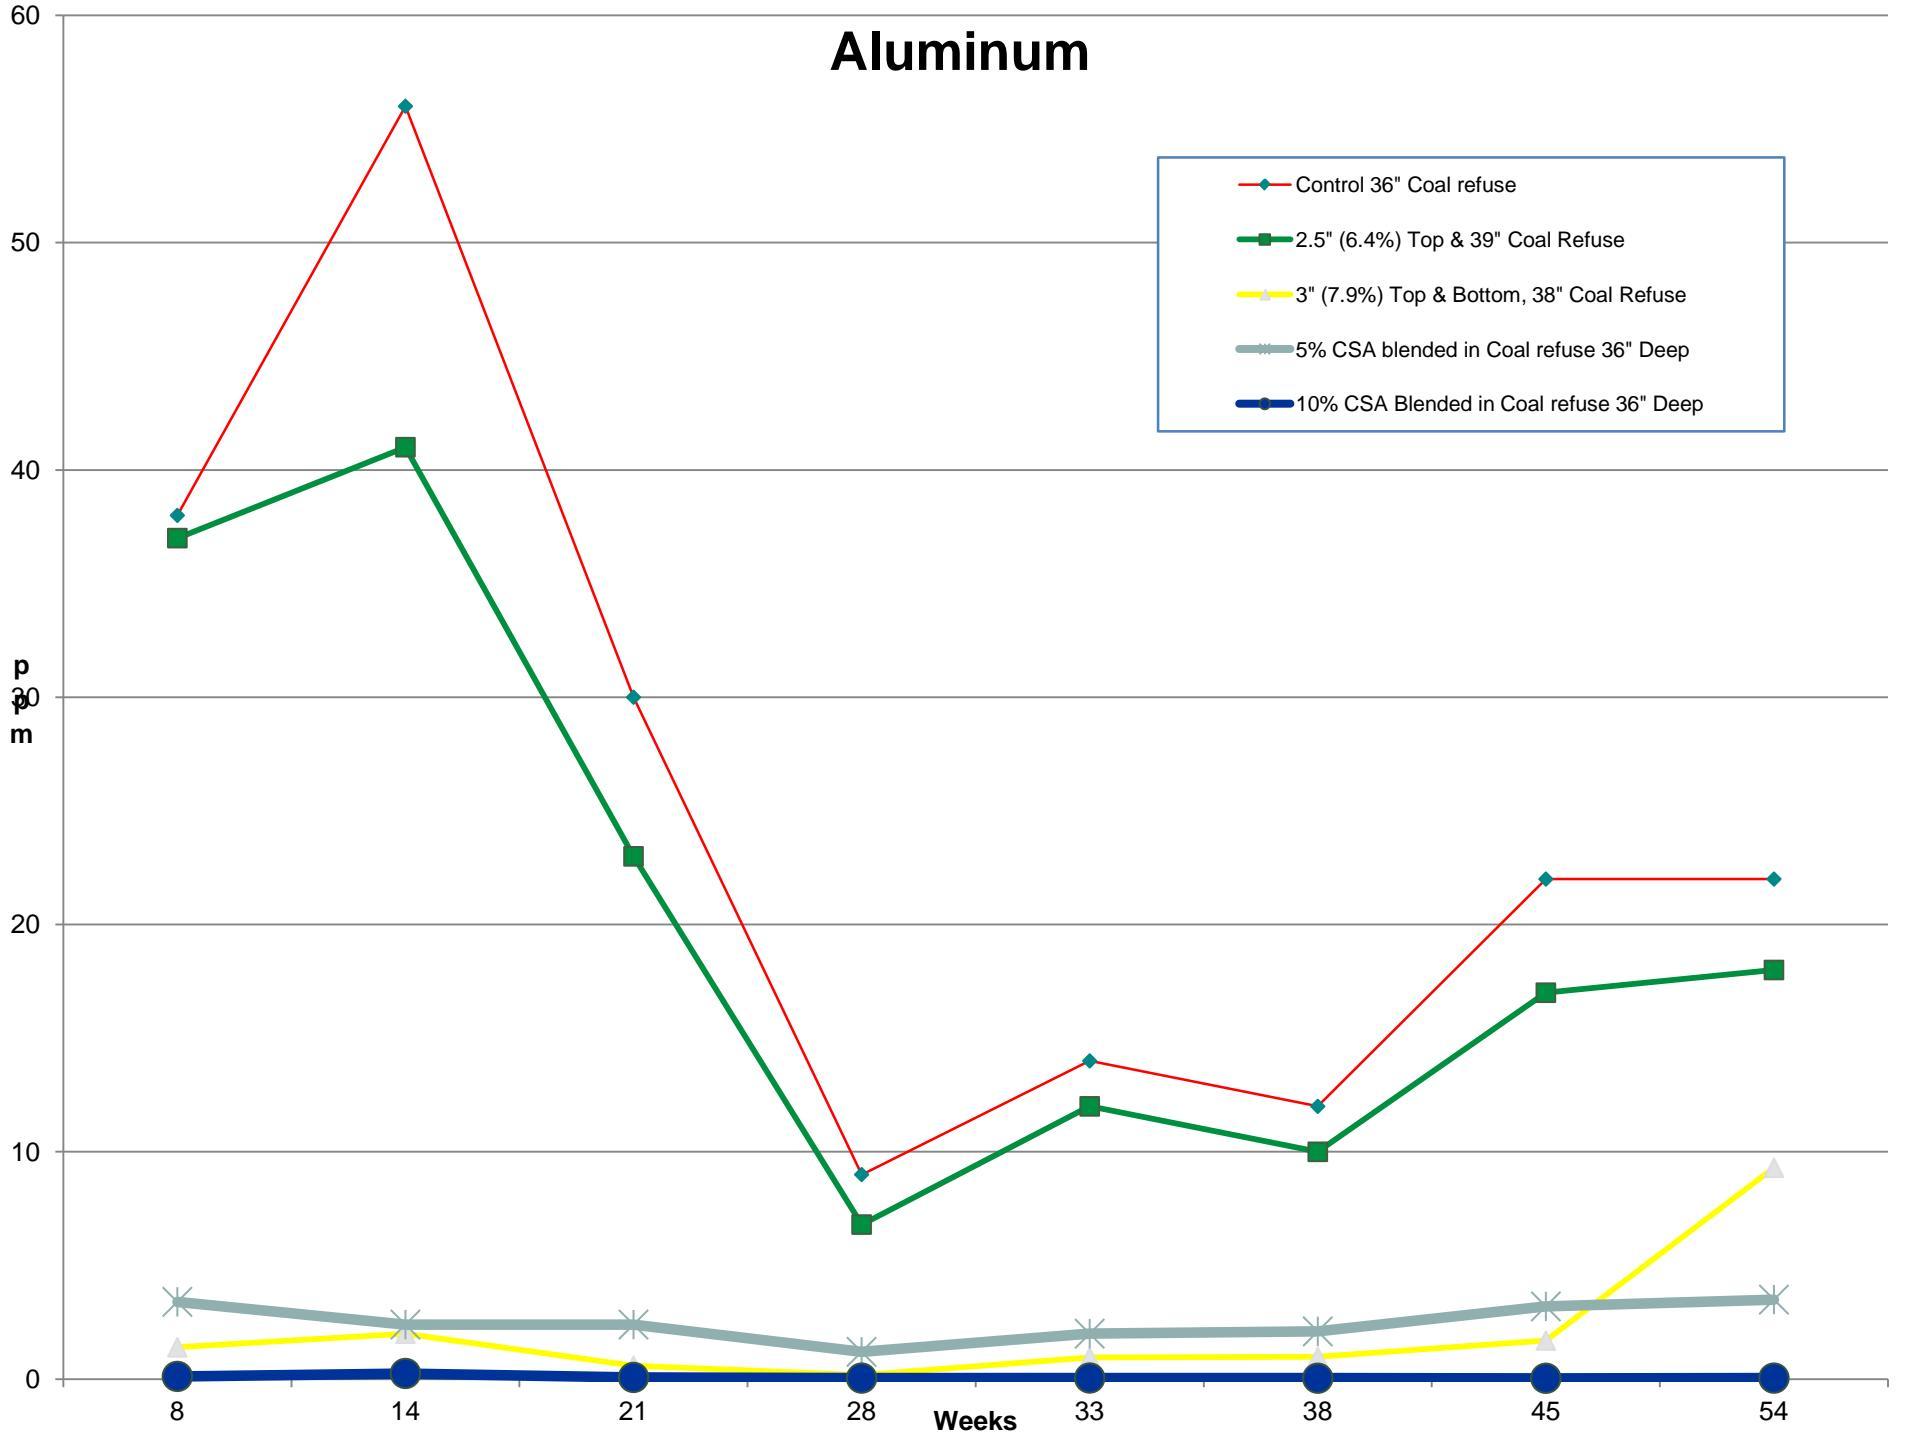
Coal Refuse Tests

- Harsco conducted an in house coal refuse study
- Simulated a coal refuse pile
- Used varying methods of applying Mineral CSA
 - Control coal refuse
 - Mineral CSA on top of refuse
 - Mineral CSA top & bottom
 - Mineral CSA 5% blended with refuse
 - Mineral CSA 10% blended with refuse
